FFI-rapport 2015/00589

Experiences from ultrasound testing – Olympus Omniscan MX and DolphiCam CF08/CF16

**Experiences from ultrasound testing
– Olympus Omniscan MX and DolphiCam CF08/CF16**

Norwegian Defence Research Establishment (FFI)

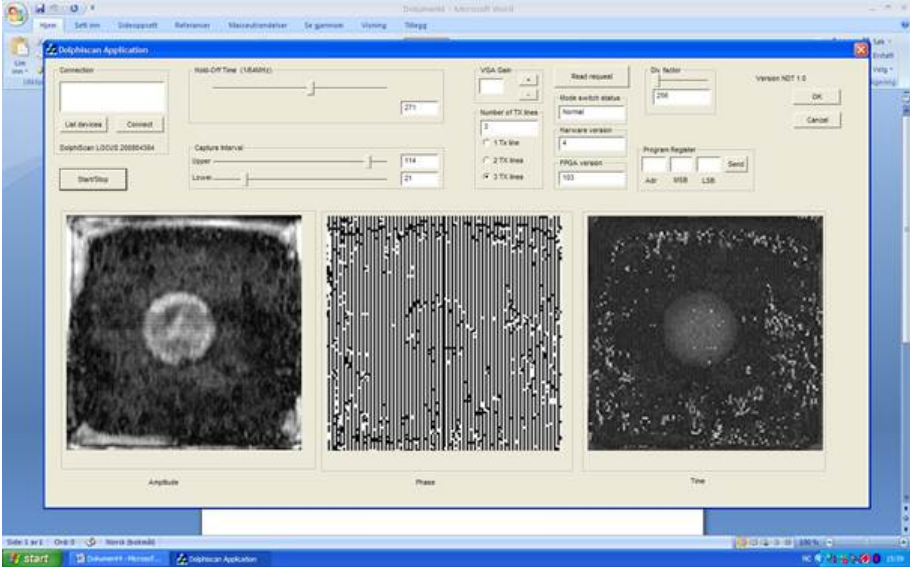
With the previous prototype version of the DolphiCam™ CF08, as reported in [1], the defects in the panel were detected in the composite thickness range from 1 mm to 6 mm. Defects that were positioned deeper in the material were not detected. Two example images are shown in Figure 5.2 and Figure 5.3 for the defects with a composite thickness of 1 mm and 6 mm, respectively.

Figure 5.2: Image from applying a prototype version of the DolphiCam™ CF08 for the CFRP panel with flat bottomed drilled holes. The composite thickness is 1 mm.

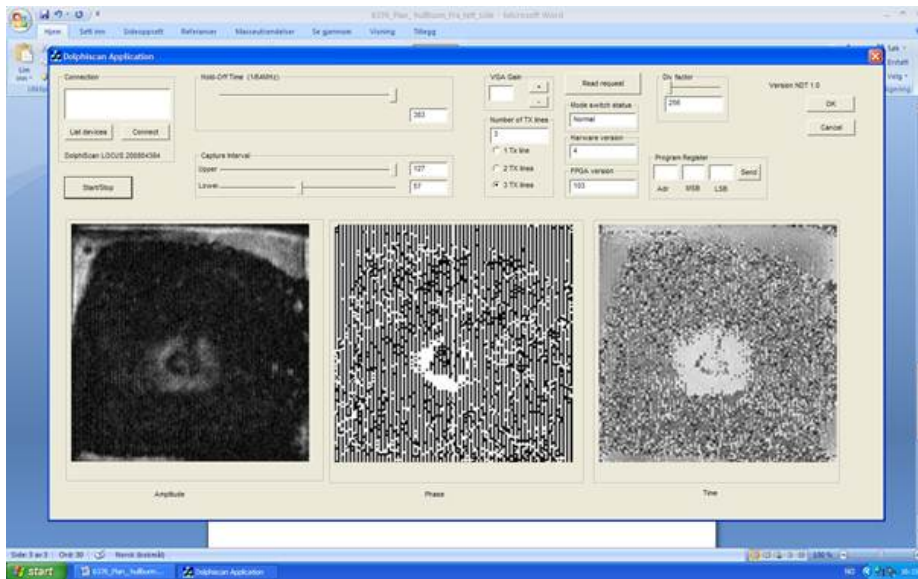
Figure 5.3: Image from applying a prototype version of the DolphiCam™ CF08 for the CFRP panel with flat bottomed drilled holes. The composite thickness is 6 mm.

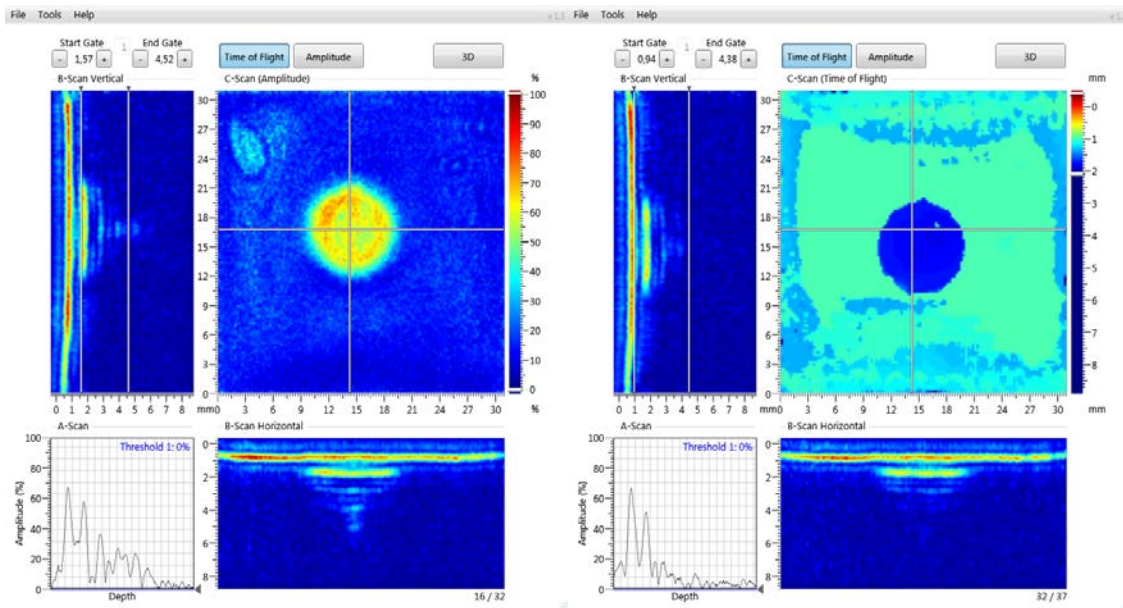
The same case as shown in Figure 5.2, now using the latest version of the DolphiCam™ CF08, is shown in Figure 5.4. Comparing the two versions of the DolphiCam™ CF08 camera, the image resolution (driven by the number and type of transducers) is nearly identical. However, the updated image processing software makes screen defect detection much easier for the operator. Furthermore, it was found that adjusting the time of flight (TOF) signal contrast, with a higher weighting around the depth of interest, provided an increased ability to detect simulated defects at the extreme minimums and maximums of the camera inspection depth range.

Figure 5.4: Image of the blind hole with composite thickness of 1 mm, using the new DolphiCam™ CF08.

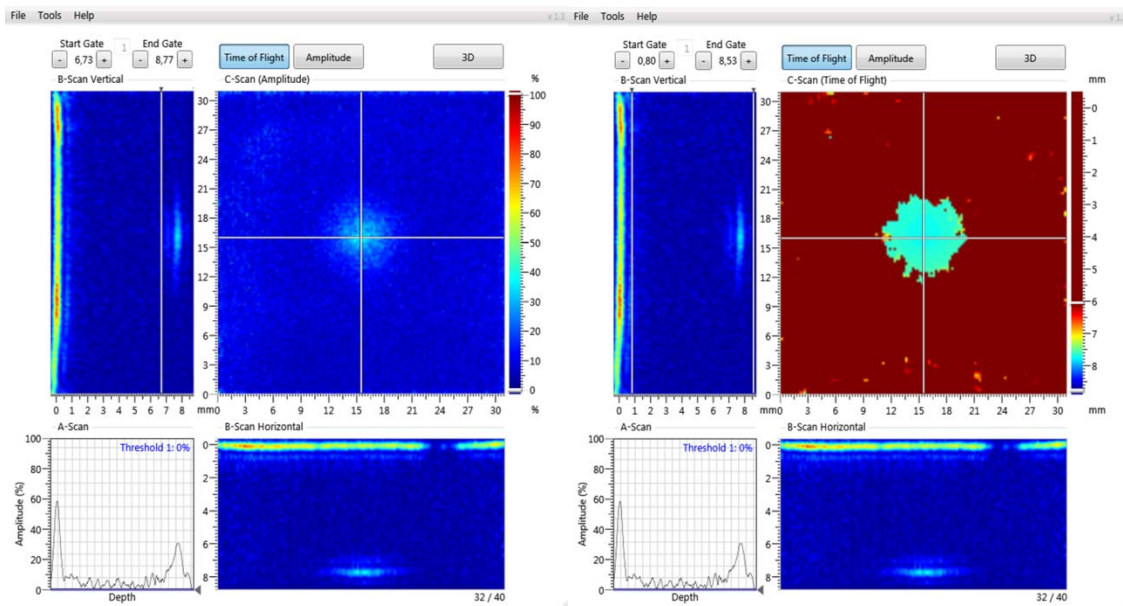
The image from the inspection of the drilled hole at a depth of 8 mm is shown in Figure 5.5, demonstrating the ability of the CF08 camera to detect defects at its maximum range. With increasing composite thickness, the details of the hole defects are decreased. However, detectability could be maintained at a consistent high level by applying a time corrected gain to the amplitude signals.

Figure 5.5: Image of blind hole with composite thickness of 8 mm, using the new DolphiCam™ CF08.

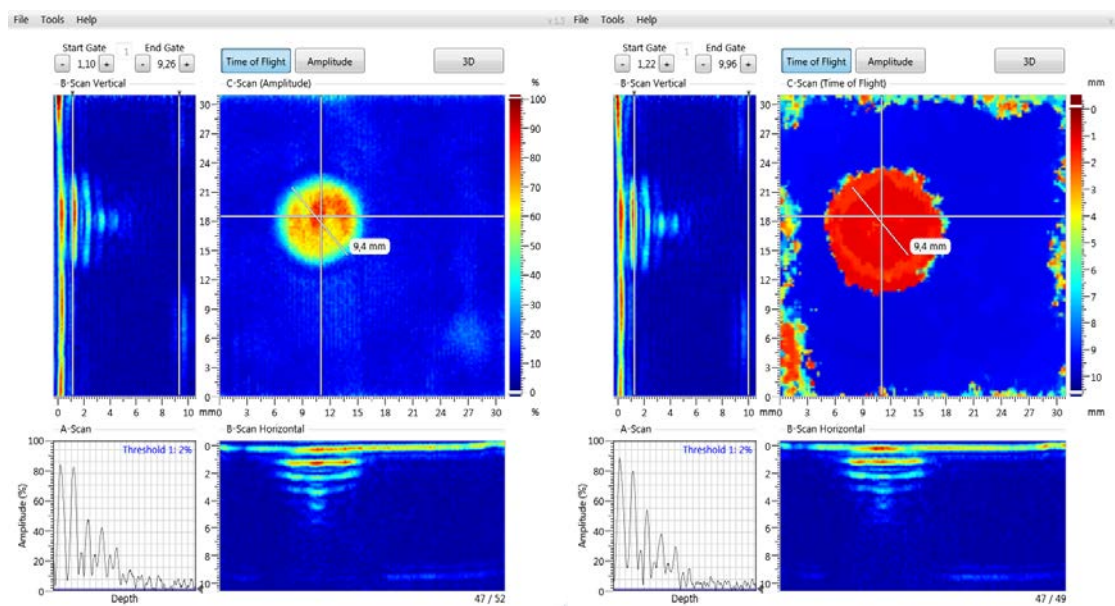
CF16 camera is the thicker dry coupling pad, which is giving the transducer matrix a larger stand-off distance from the composite surface. The higher amplitude of the transmitted pulses for the CF16 camera can be seen in Figure 5.6, where the signal reflections from the near-field surface of the blind hole face have large amplitudes. DolphiCam™ CF16 performs qualitatively the same as DolphiCam™ CF08 for simulated near-field defects. In this case, the TOF signal contrast for the near-field defect was not weighted.

Figure 5.6: Image of a blind hole with composite thickness of 1 mm, using the DolphiCam™ CF16 camera.

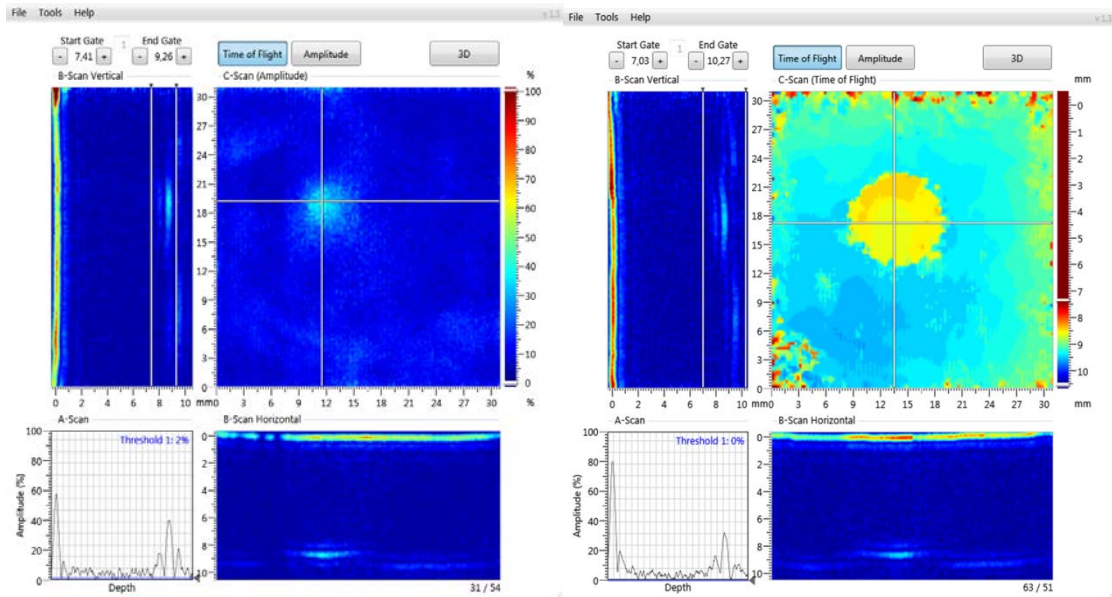
The deepest simulated and detected defect, consisting of a 1 mm deep blind hole with a composite thickness of 9 mm, is given in Figure 5.7. In this case, the TOF scale was adjusted for higher contrast, due to the small distance (i.e. 1 mm) between the blind hole face depth and the back surface of the composite. The TOF signals have a higher contrast weighting applied around the depth of interest to better distinguish the characteristics of the flat bottomed blind hole. Increasing composite thickness led to a decrease in the detail imagery of the defects. However, detectability could be maintained at a consistent high level by applying a time corrected gain to the amplitude signals for the DolphiCam™ CF16 camera.

Figure 5.7: Image of a blind hole with composite thickness of 9 mm, using the DolphiCam™ CF16 camera.

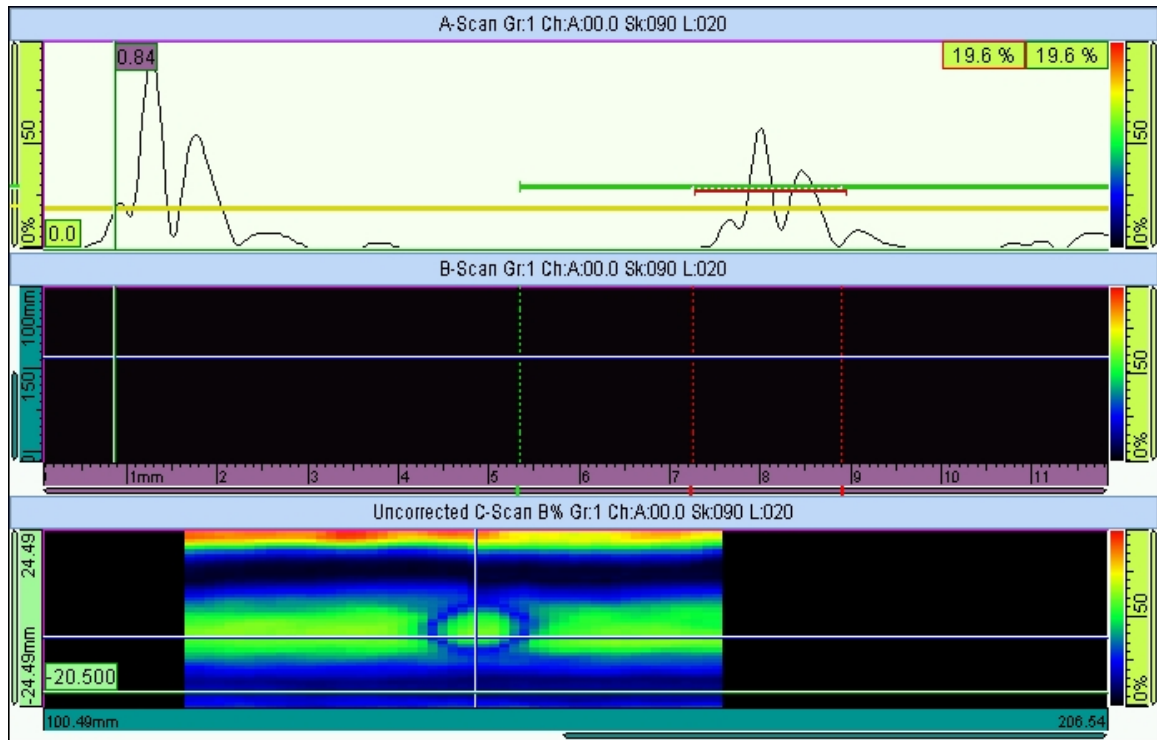
The Omniscan MX instrument from Olympus, see Section 3, was also used to inspect the various depths of boreholes in the CFRP panel. A representative result from the flat bottomed blind hole inspections by the Omniscan MX is given in Figure 5.8, in this case for the hole with a composite thickness of 7 mm. The signal from the face surface of the blind hole can be seen in the A-scan as a signal return with approximately 60 per cent amplitude of the transmitted pulse. Furthermore, the high degree of flexibility in the Omniscan MX system allowed for all depths of holes to be imaged with the same degree of detectability and clarity.

Figure 5.8: Image of the blind hole with a composite thickness of 7 mm, using the Omniscan MX instrument.

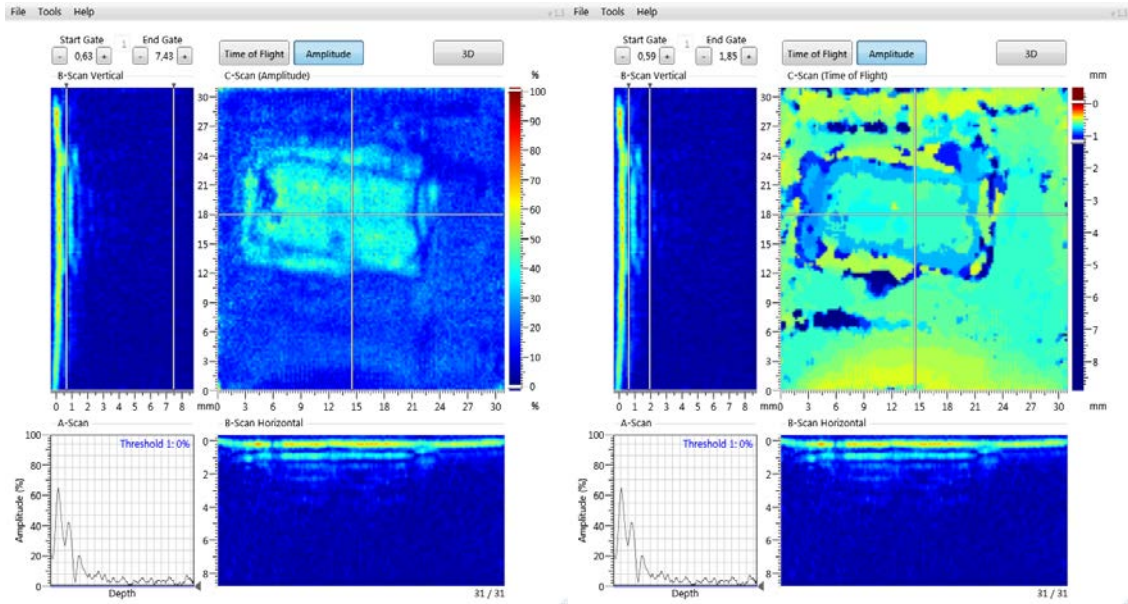
measurement. Furthermore, for the shallowest inclusion (in Figure 6.7), there exist features around the edges of the rectangular inclusion that could be delamination, or an epoxy pocket. This feature was captured in multiple scans of the 0.5 mm deep defect. Other techniques should be applied for investigating the presence of an epoxy pocket.

Figure 6.7: Image of rectangular two layer Teflon® inclusion at a depth of 0.5 mm, using the DolphiCam™ CF08 camera.

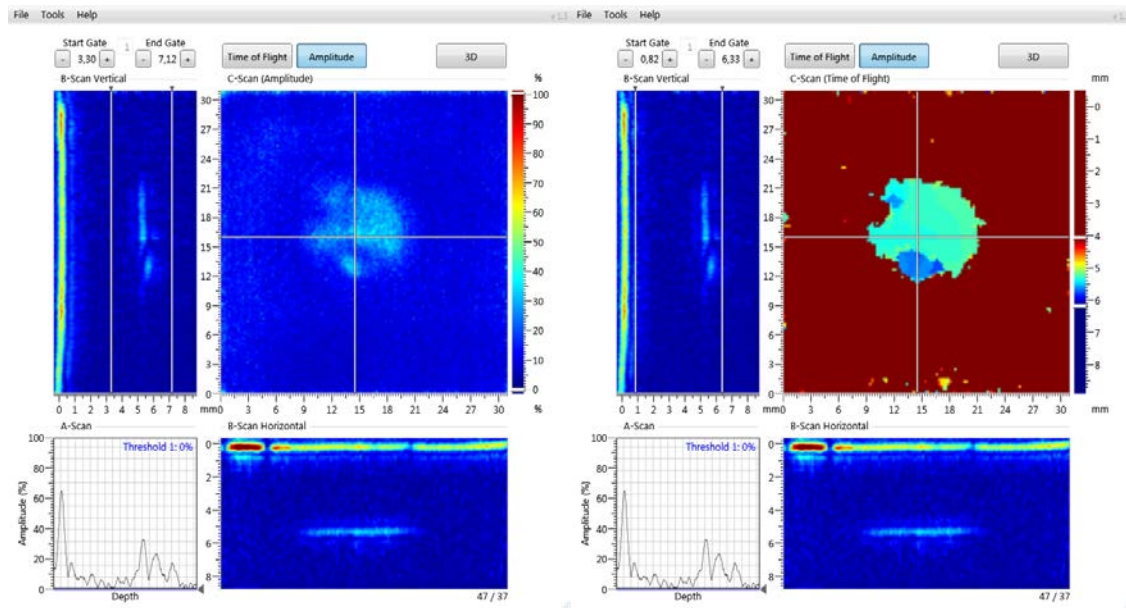
The imagery of the 5 mm deep single layer Teflon® inclusion displayed an apparent out of plane, or wavy, feature. This waviness from 0.5 to 1.0 mm was measured in multiple scans of the inclusion, and determined not to be a signal artefact. The feature can be observed in the lower centre of the inclusions in Figure 6.10.

Figure 6.10: Image of circular single layer Teflon® inclusion at a depth of 5 mm, using the DolphiCam™ CF08 camera.

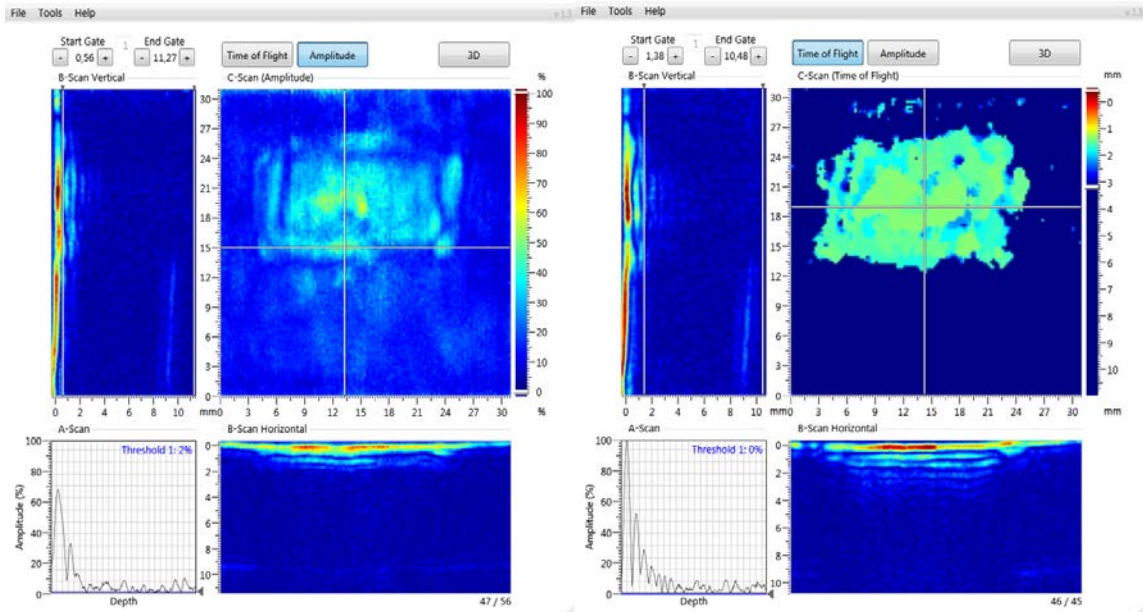
As shown in Figure 6.19, there exist features around the edges of the rectangular inclusion that could be a delamination or an epoxy pocket. This feature was captured in multiple scans of the 0.5 mm deep defect. Other inspection techniques may be required for further analysis.

Figure 6.19: Image of a rectangular two layer Teflon® inclusion at a depth of 0.5mm, using the DolphiCam™ CF16 camera.

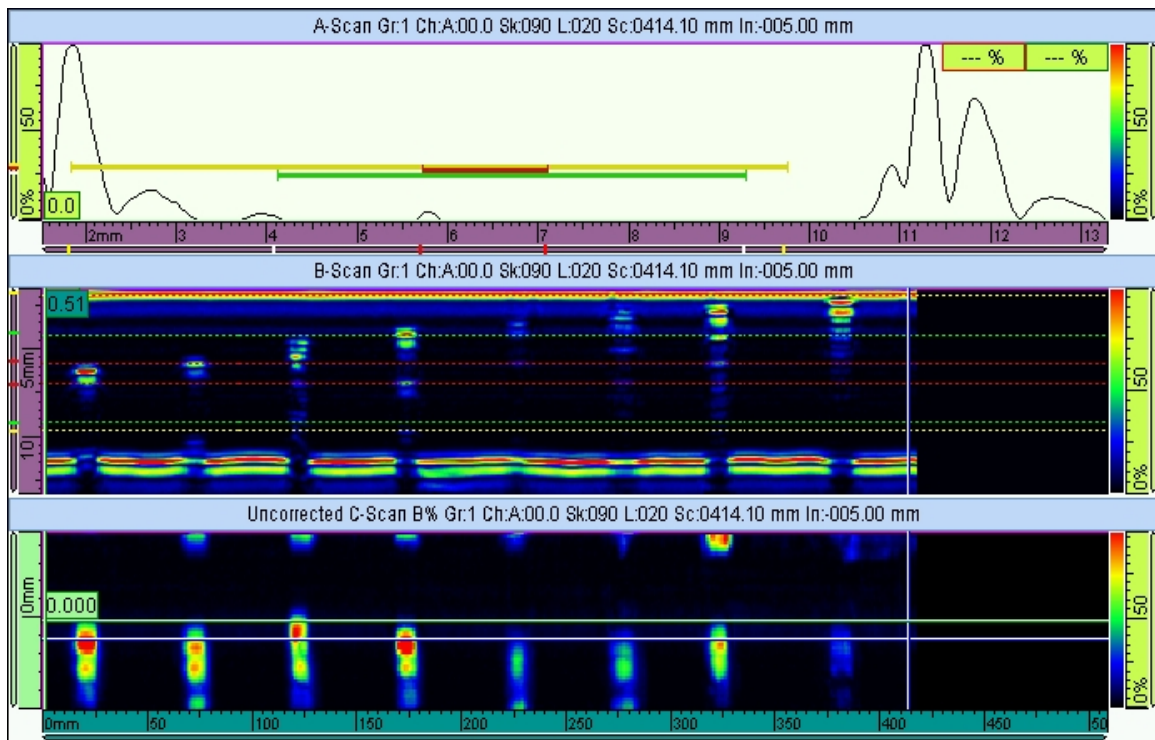
The results of an Olympus Omniscan MX linear encoded scan of the rectangular aluminium inclusions are displayed in Figure 6.26. The images indicate the detected depth and areal size of the inclusions. Variations in the displayed signal strength of the B-scan for the simulated defects are due to the profile line intersection, as displayed in the C-scan. Significant signal reflections are observed for both near field and far field defect returns. All rectangular aluminium inclusions were easily detected with the scan area of 420mm x 64mm, completed in less than one minute.

Figure 6.26: Image of the rectangular aluminium inclusions, using Omniscan MX.

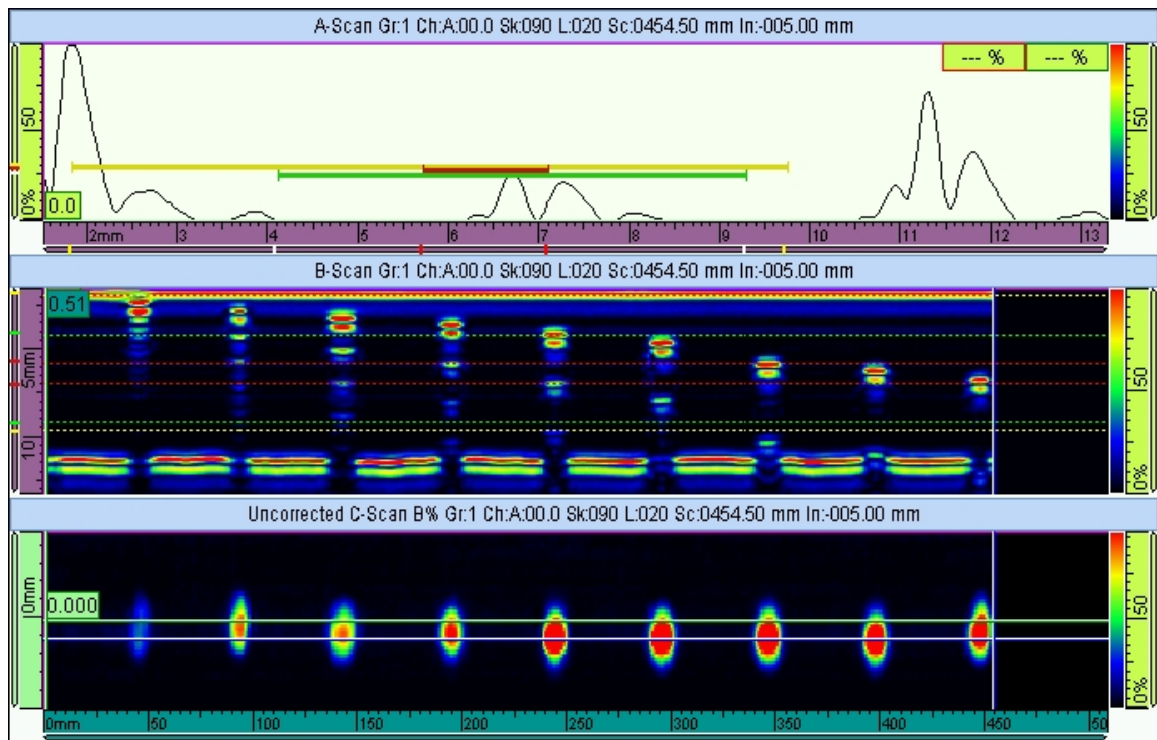
The results of an Olympus Omniscan MX linear encoded scan of the circular aluminium inclusions are presented in Figure 6.27. The A-scan, B-scan, and C-scan of the simulated defects are displayed. The images indicate the detected depth and areal size of the inclusions. Variations in the displayed signal strength of the B-scan for the simulated defects are due to the profile line intersection as displayed in the C-scan. Significant signal reflections are observed for both near-field and far-field defect returns. It can be seen that with the system settings optimized to detect deeper inclusions, the level of detail in the near-field results deteriorates.

Figure 6.27: Image of the circular aluminium inclusions, using Omniscan MX.

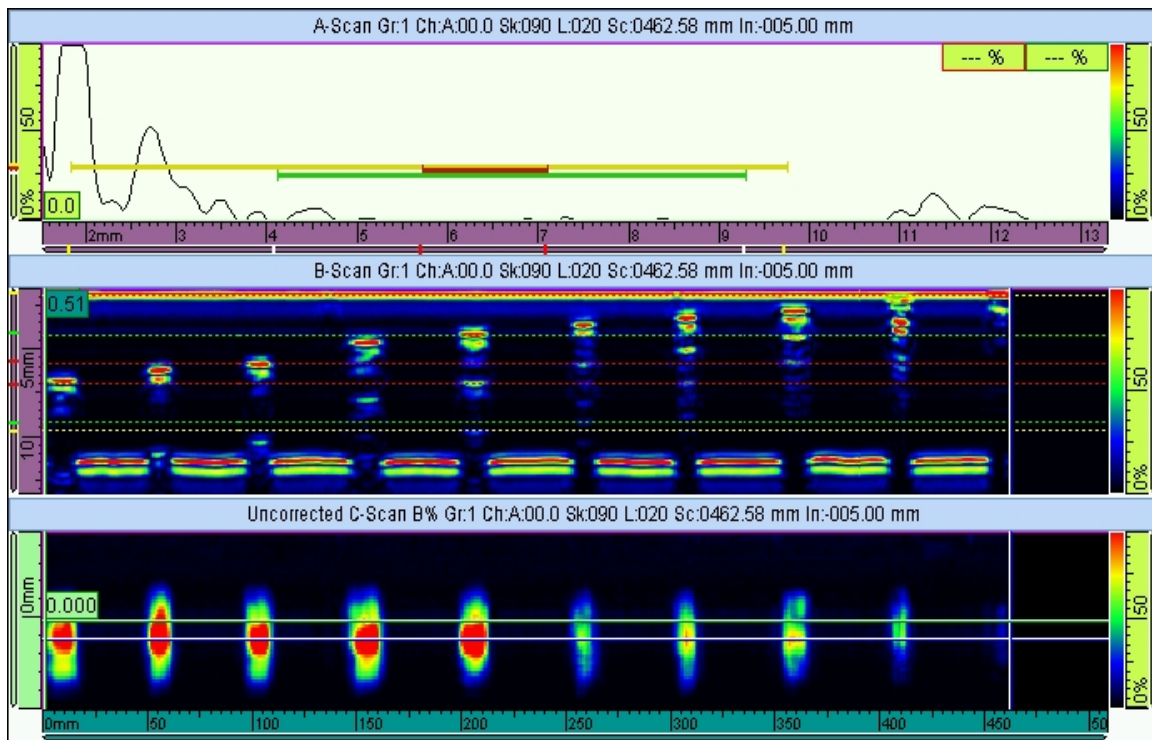
The one layer Teflon inclusions were also inspected by an Olympus Omniscan MX linear encoded scan. The results are shown in Figure 6.28. The A-scan, B-scan, and C-scan of the simulated defects are displayed. The images indicate the detected depth and areal size of the inclusions. Significant signal reflections are observed for both near-field and far-field defect returns, as shown by the multiple signal returns. It can be seen that with the system settings optimized to detect deeper inclusions, the level of detail in the near-field results deteriorates. Details that may be present in the Teflon tape inclusions, for example wrinkles or out of plane features, are difficult to detect with the area scan of the panel.

Figure 6.28: Image of the rectangular single layer Teflon inclusions, using Omniscan MX.

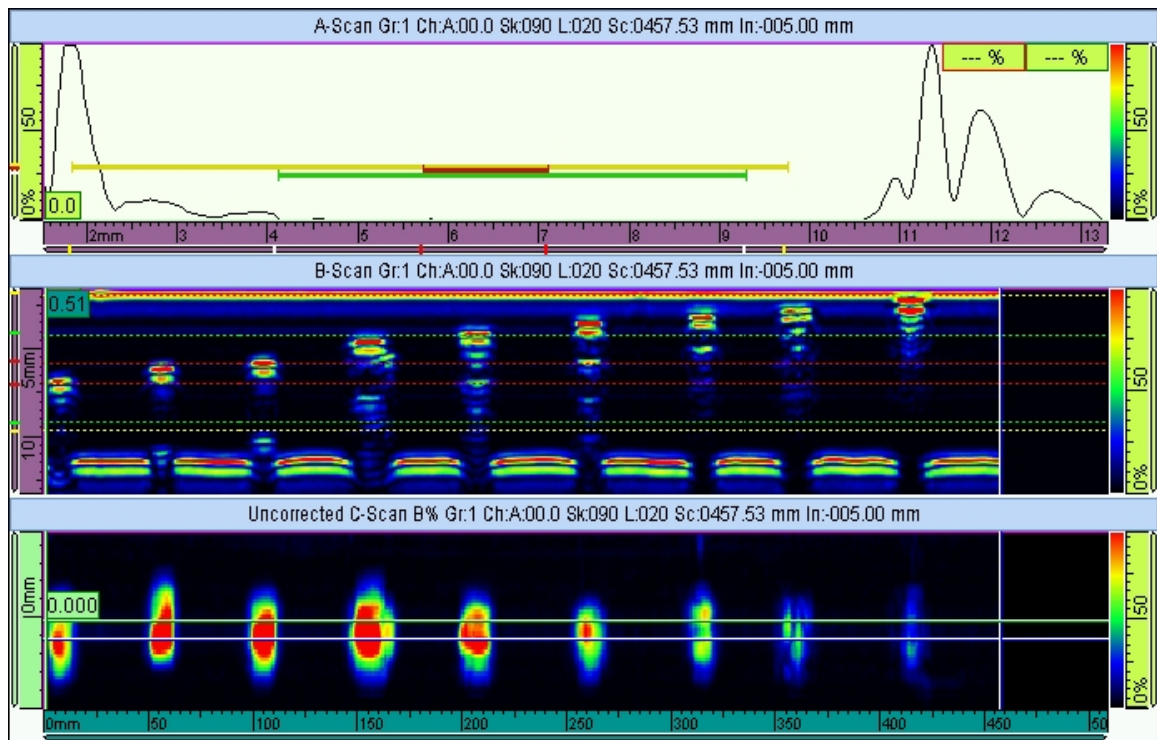
The results for the Olympus Omniscan MX linear encoded scan of the rectangular two layer Teflon® inclusions are presented in Figure 6.29. The A-scan, B-scan, and C-scan of the simulated defects are displayed. The images indicate the detected depth and areal size of the inclusions. Significant signal reflections are observed for both near-field and far-field defect returns, as shown by the multiple signal returns. Possible wrinkles or epoxy pockets in both the 1 mm and 3.5 mm deep inclusions are observed on the images. However, it is difficult to determine the systems settings that are suited for detecting the existence of inclusions over a wide range of depths. Supplementary techniques are required.

Figure 6.29: Image of the rectangular two layer Teflon inclusions, using Omniscan MX.

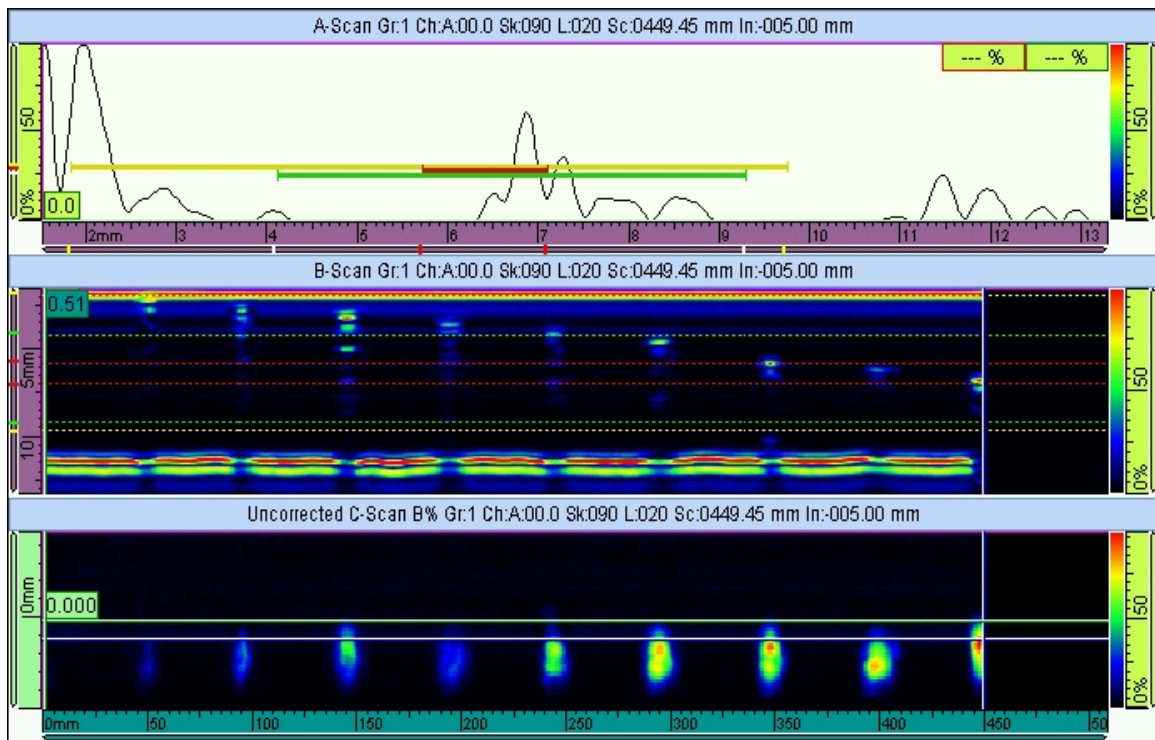
The results from a linear encoded scan using the Olympus Omniscan MX of the circular one layer of Teflon® tape inclusions at depths ranging from 0.5 mm to 5 mm are displayed in Figure 6.30. The A-scan, B-scan, and C-scan of the simulated defects are displayed. The A-scan shows a typical signal return from the 5 mm deep inclusion. The profile of the B-scan is taken off-centre from the circular inclusions, and therefore does not have the highest signal return shown. Inclusions that are deeper than 2 mm give a higher amplitude return signal, as the system settings were optimized for the greatest range of depths. The results from the Omniscan MX inspection show that for the single layer Teflon circles, the detectability is high. However, accurate inclusion shape determination is difficult.

Figure 6.30: Image of the circular single layer Teflon inclusions, using Omniscan MX.

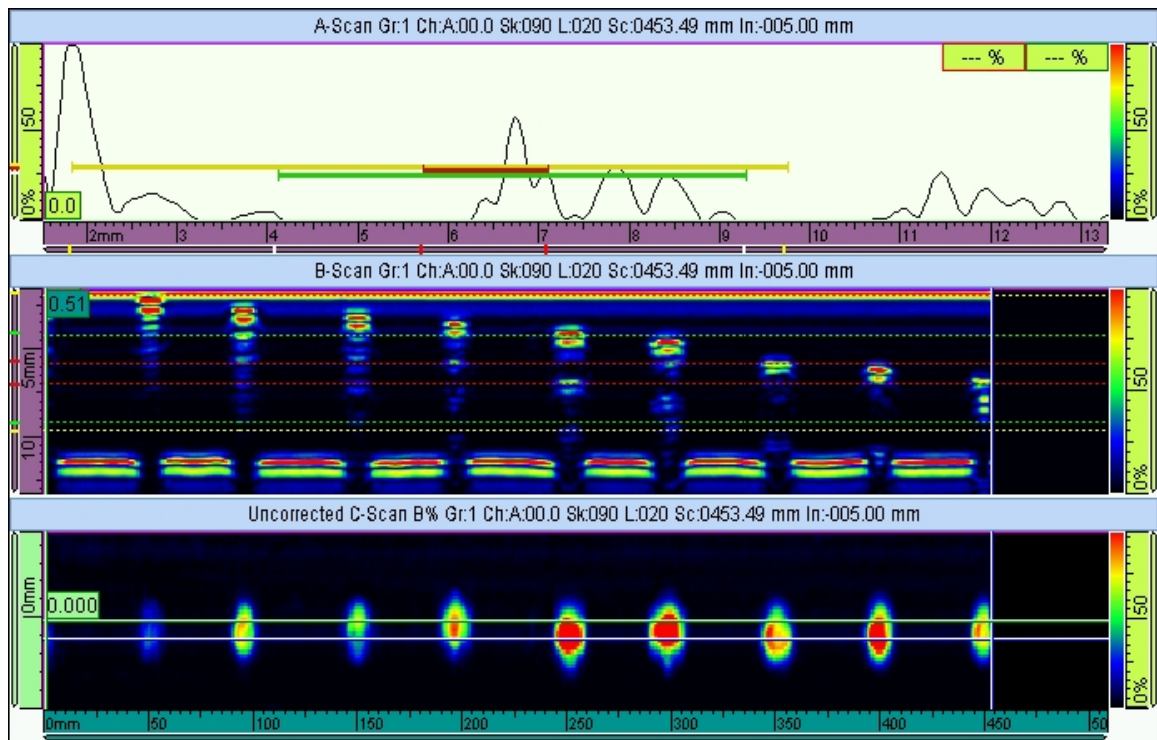
A linearly encoded scan using the Olympus Omniscan MX was performed on the circular two layers of Teflon® tape inclusions at depths ranging from 0.5 mm to 5 mm. The results of the scan are presented in Figure 6.31, and the A-scan, B-scan, and C-scan of the simulated defects are displayed. The A-scan shows a typical signal return from the 5 mm deep inclusion. The inclusions return high amplitude signals at all depths greater than 0.5 mm. Approximate diameter measurements within 1 mm of the actual were made.

Figure 6.31: Image of the circular two layer Teflon® inclusions, using Omniscan MX.

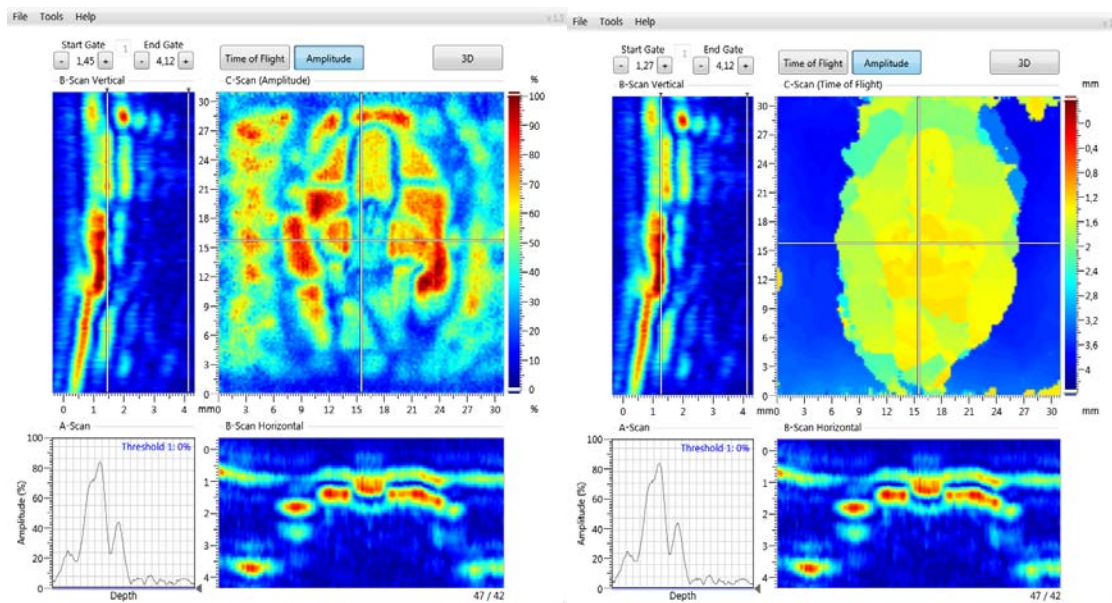
The results for the DolphiCam™ CF08 inspection of the 70 J and 90 J impacts are presented in Figure 7.1 and Figure 7.2, respectively. The figures contain B-scans along two orthogonal profiles of the image, and C-scans containing amplitude returns (on the left) and time of flight (TOF) information (to the right). The TOF colour gradient scaling was not adjusted for the 70 J and 90 J impact cases. For both impact energy levels, the severity and depth of delaminations can be seen in both the B-scans and the TOF images. The images show that the delaminations increase in size as the damage propagates deeper into the CFRP panel. The 3.0 mm thick panel with impact energy 70 J contains delamination damage throughout the thickness, while the 5.0 mm panel delamination damage propagated to a depth of approximately 3.0 mm.

Figure 7.1: Images of the 70 J impact damage in the 3.0 mm panel, using the DolphiCam™ CF08 camera.

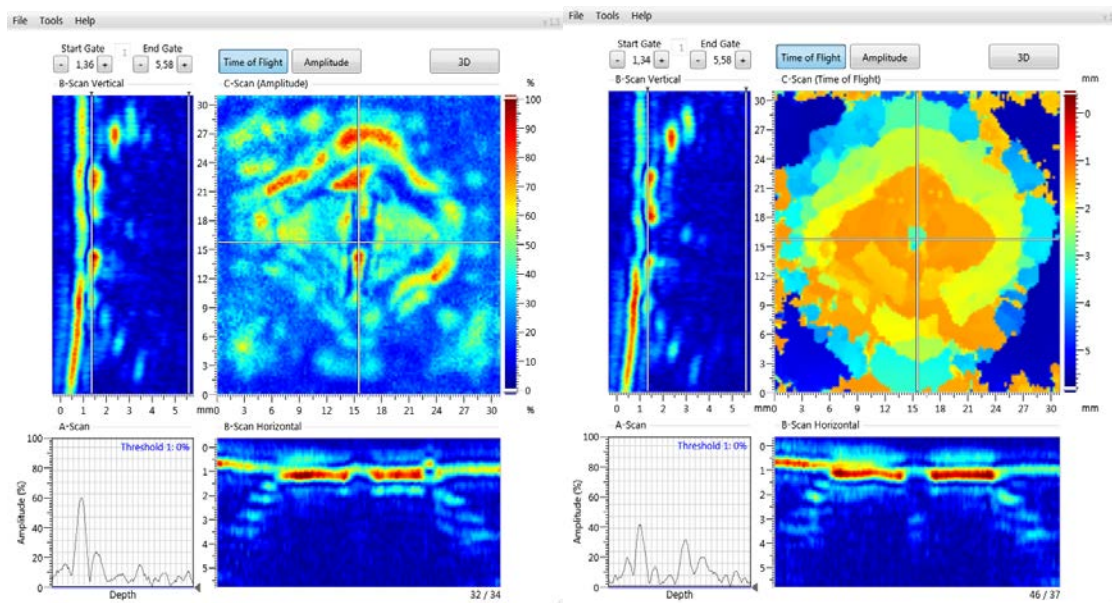
Figure 7.2: Images of the 90 J impact damage in the 5.0 mm panel, using the DolphiCam™ CF08 camera.

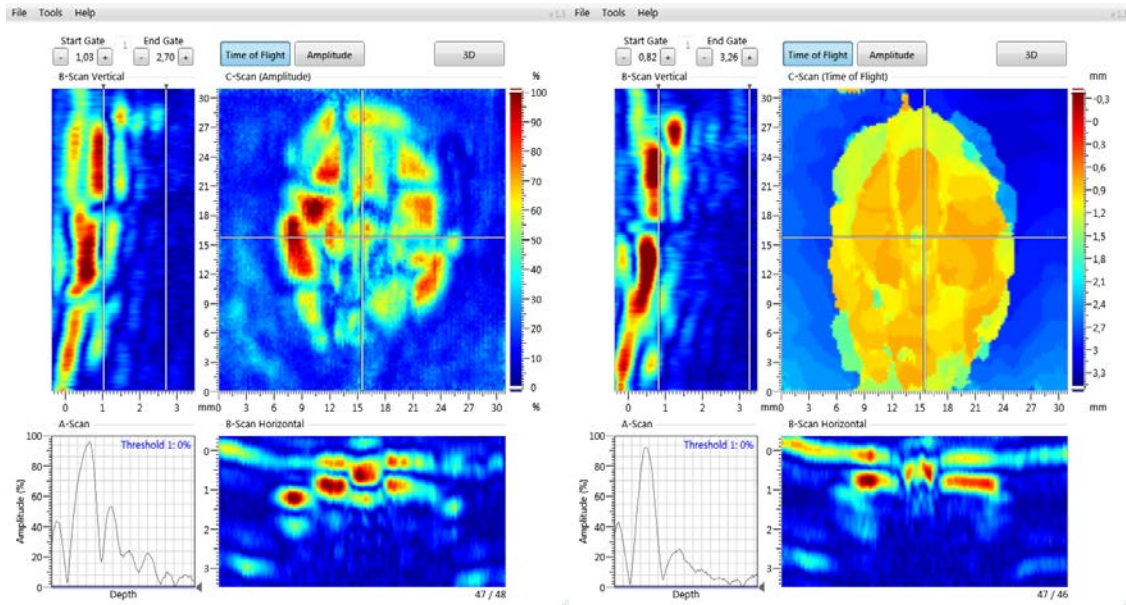
Figure 7.3: Image of the 70 J impact damage in the 3.0 mm panel, using DolphiCam™ CF16.

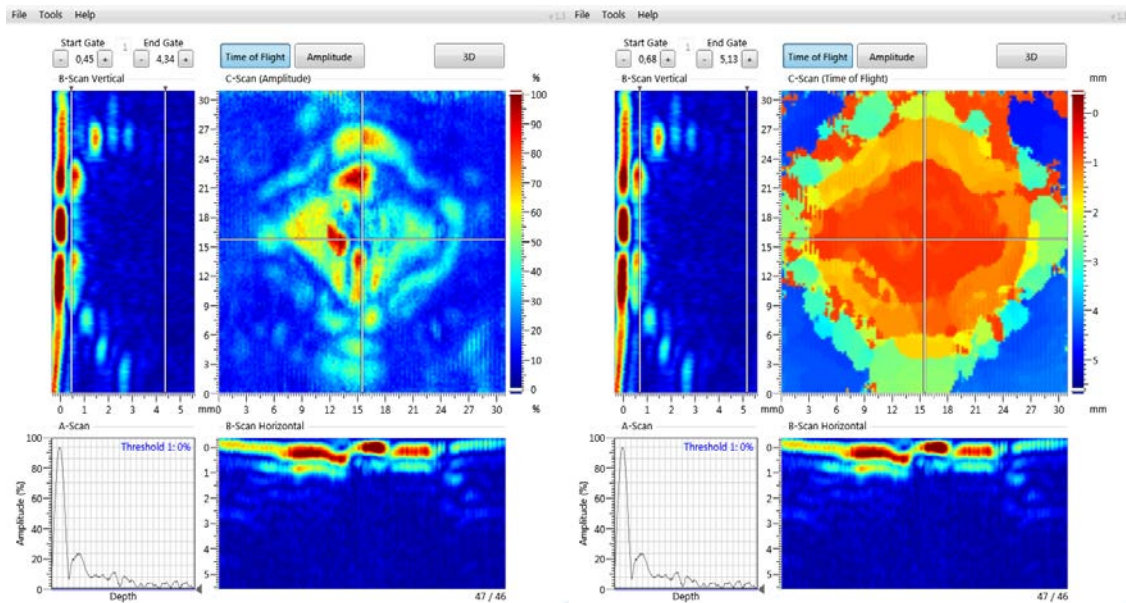
Figure 7.4: Image of the 90 J impact damage in the 5.0 mm panel, using the DolphiCam™ CF16 camera.

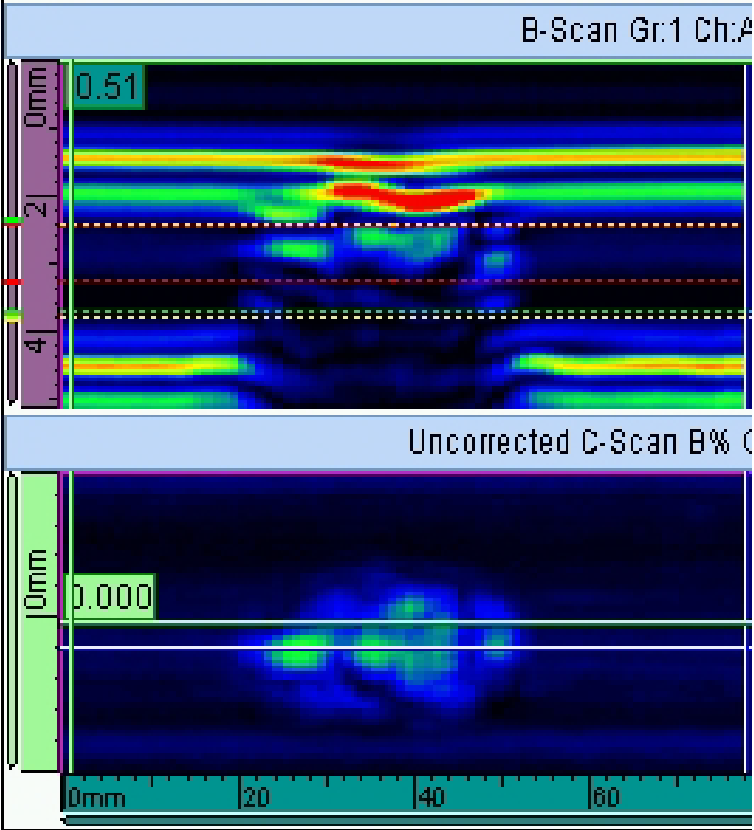
The results from a linear encoded Omniscan MX scan for the 70 J and 90 J impacts are presented in Figure 7.5 and Figure 7.6, respectively. The images show a B-scan and C-scan image of each damage location. The C-scan images of the impact delamination damages provide good measurements of the total delamination area and shape. However, the individual ply

Figure 7.5: Image of the 70 J impact damage in the 3.0 mm panel, using Omniscan MX.

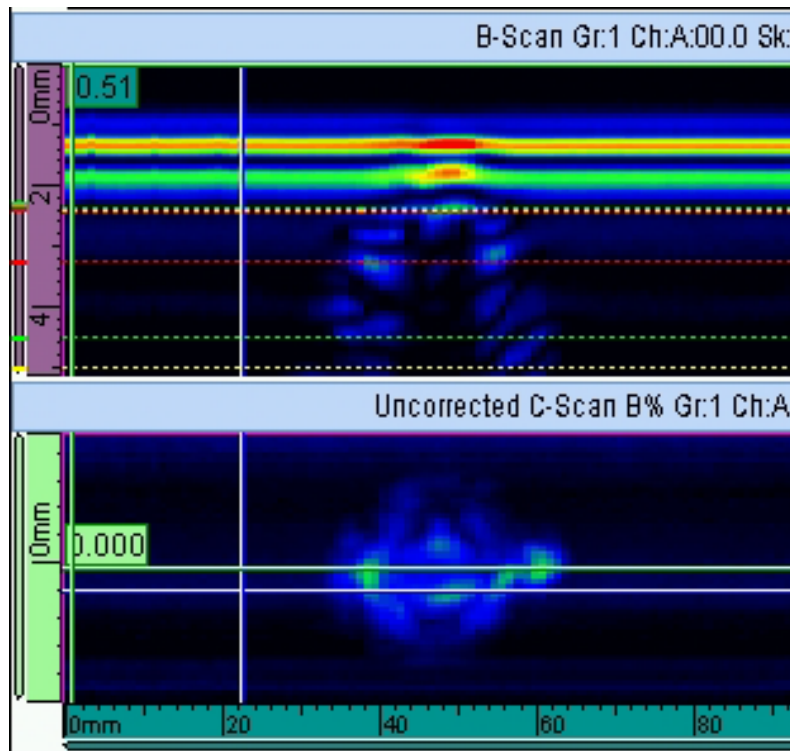
delaminations are difficult to differentiate. The Omniscan MX displays the B-scan image for one selected profile, which can be adjusted during and after the completion of the scan. This helps to determine if the displayed signal returns are delamination features or secondary reflections resulting in false returns. The depth of damages was measured to be 3.0 mm for both the 3.0 mm and 5.0 mm thick panels.

Figure 7.6: Image of the 90 J impact damage in the 5.0 mm panel, using the Omniscan MX.

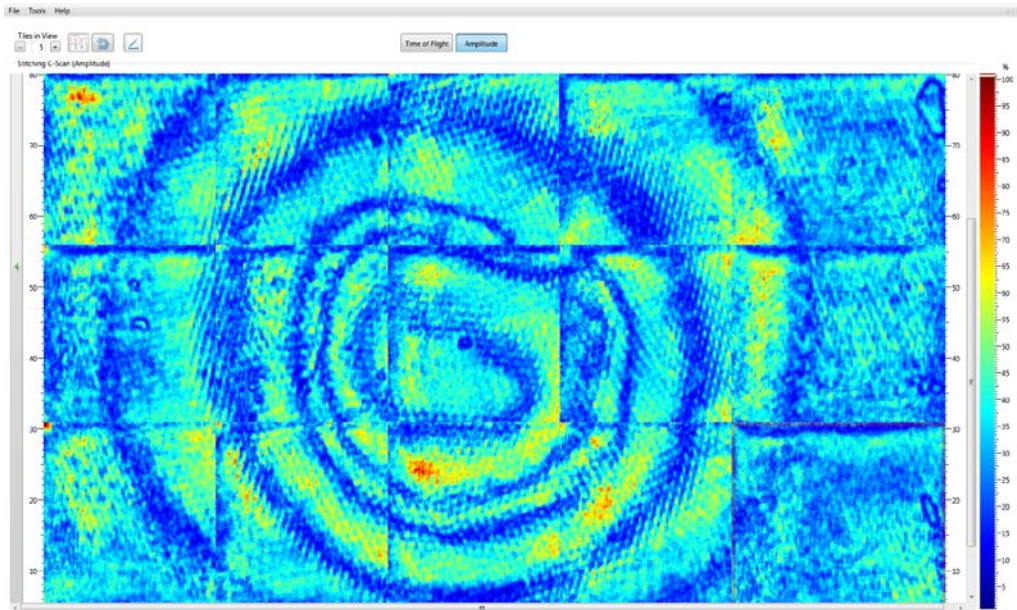
The DolphiCam CF08 has been specially developed for ultrasonic imaging of CFRP materials. However, the camera did provide information on the repair layers shape and possible concentrations of epoxy, as shown in Figure 8.1 and Figure 8.2. Settings for the CF08 camera that are needed to produce the amplitude images given in the figures, can be found in Table 1.

Figure 8.1: DolphiCam™ CF08 stitched image of top-right scarf repair to glass fibre/Nomex honeycomb core sandwich panel.

The non-circularity of some of the scarf repair layers in Figure 8.1 could be indicative of regions of high epoxy resin concentration. Such features are important to detect and monitor, as they can be future sites for damage nucleation to the repair.

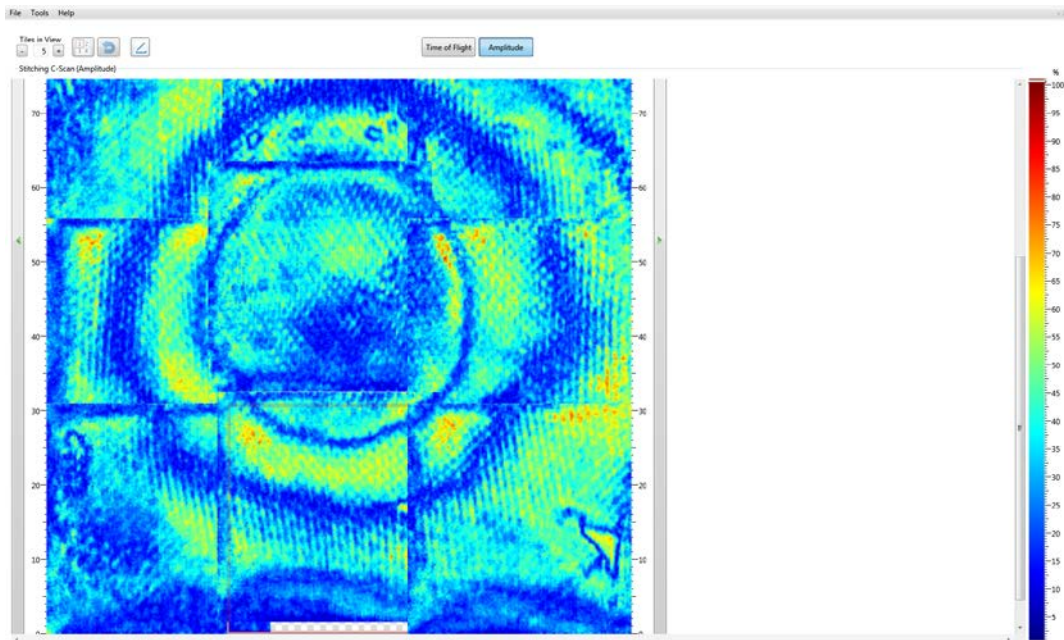
Figure 8.2: DolphiCam™ CF08 stitched image of bottom-left scarf repair to glass fibre/Nomex honeycomb core sandwich panel.

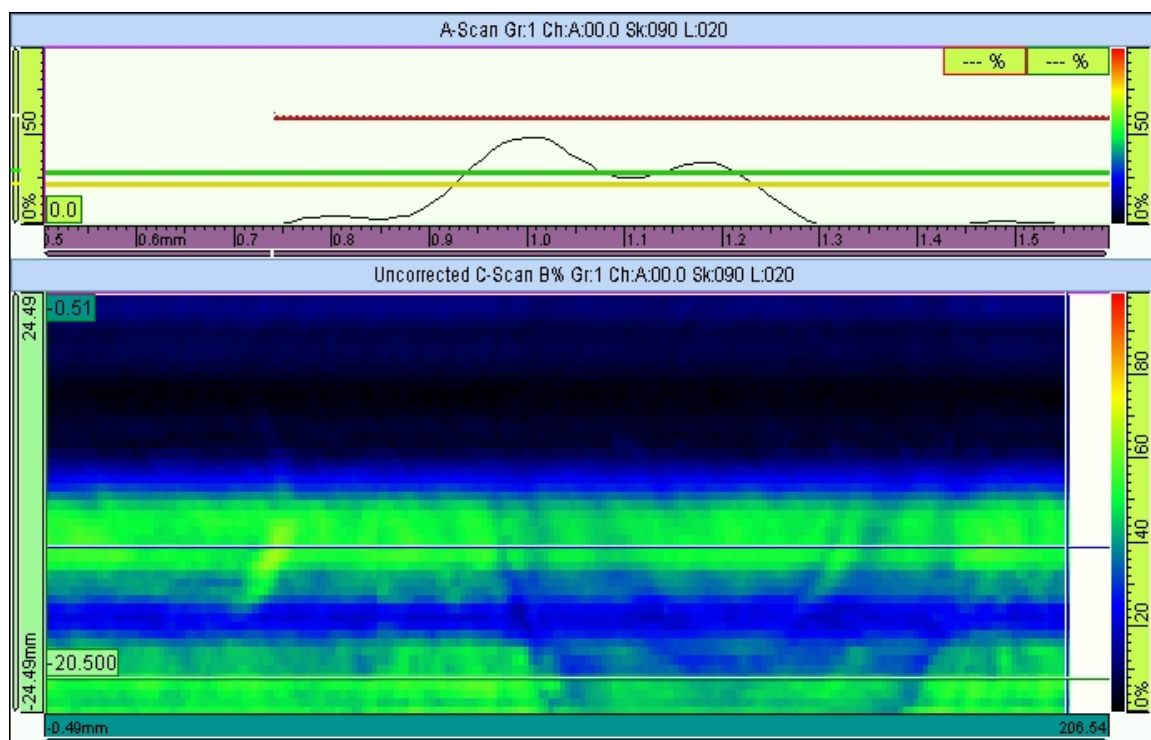
In Figure 8.3, the Omniscan MX imagery of the bottom-left scarf repair in the glass fibre/Nomex honeycomb sandwich panel is shown. Ultrasonic imaging of the glass fibre scarf repair shows that it is possible to detect the different layers of the patch with the amplitude information.

Figure 8.3: Omniscan MX A-scan and C-scan imagery of the bottom-left scarf repair of the glass fibre/Nomex honeycomb sandwich panel.
