FFI-rapport 2013/02241

COMPACT project: Hydro burst testing of impact damaged four-inch pressure vessels

Norwegian Defence Research Establishment (FFI)

20 September 2013

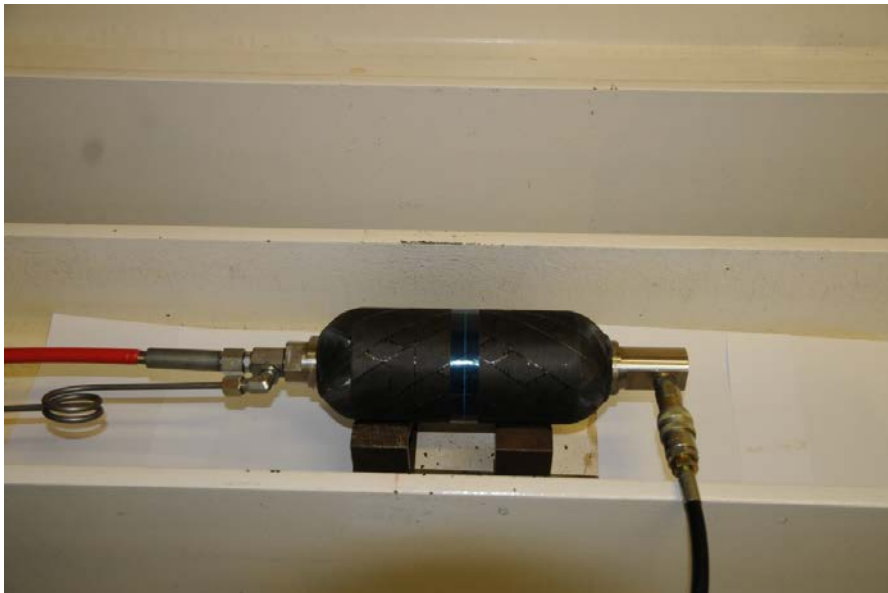
Figure 2.1 Mounting of the pressure vessel in the burst test chamber.

In short, the hydro burst test is carried out by first mounting the vessel into the test rig, as shown in Figure 2.1. The vessel is then filled with water, and a piston pump is used to increase the pressure until the vessel bursts. The pressure value at burst is the reported *burst pressure value*.

Note that prior to HBT, the vessels are sealed using a polymer liner (Rencast 6427A/Rencast 5427B) to make it water proof.

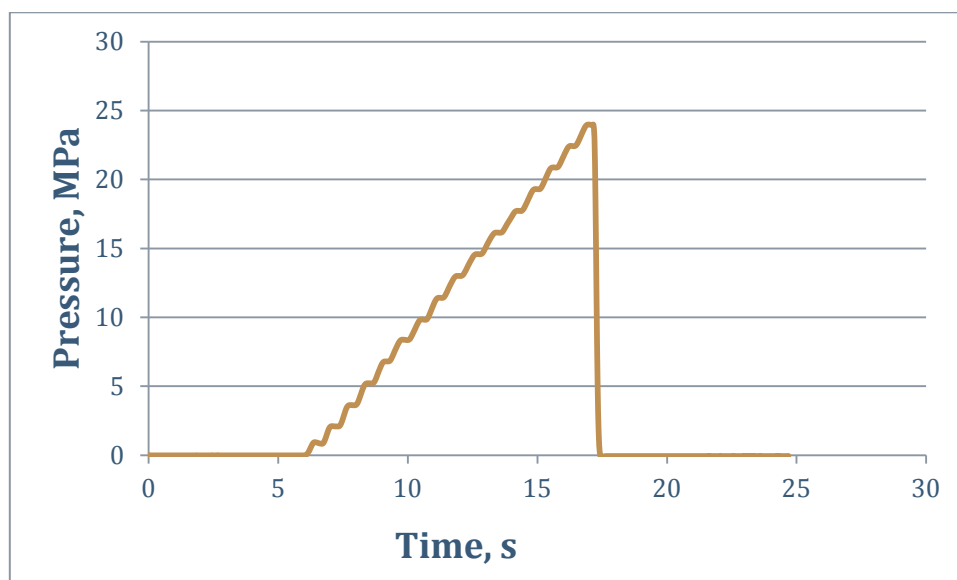
Figure 3.2 Pressure curve for CP-1.

Figure 3.2 to Figure 3.12 show the pressure curve for the eleven hydro burst tested pressure vessels. The peak pressure value is the reported burst pressure value, see Table 3.1.

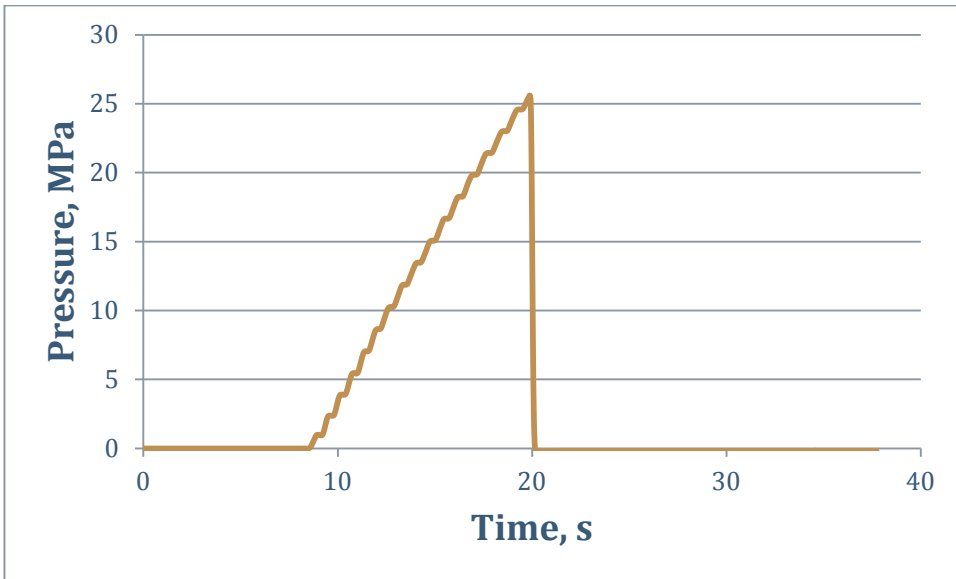
Figure 3.3 Pressure curve for CP-2.

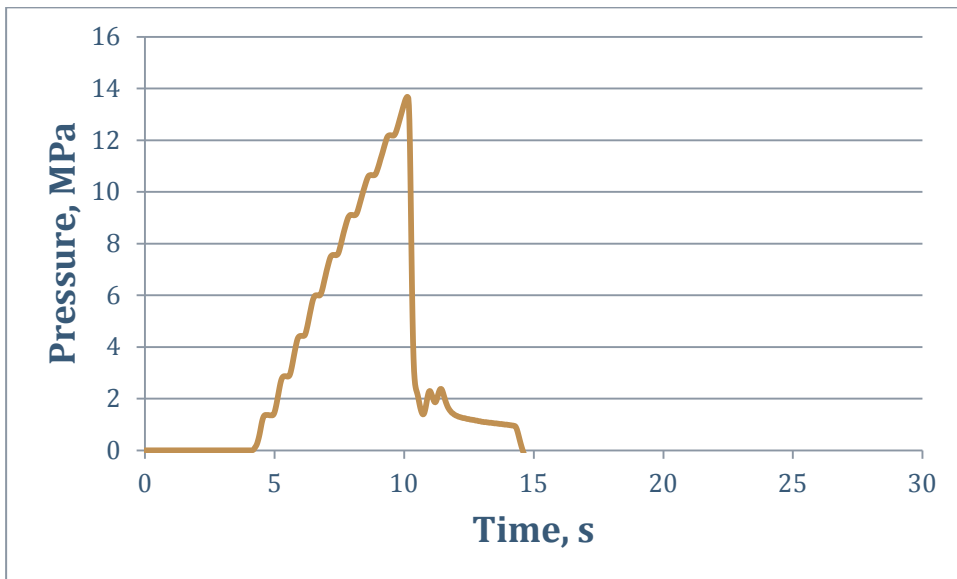
Figure 3.7 Pressure curve for CP-6.

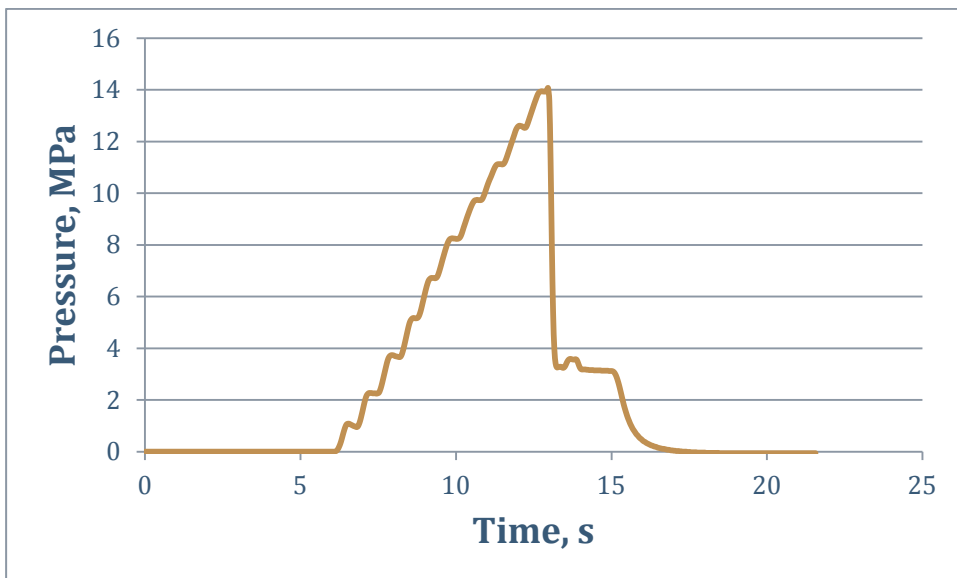
Figure 3.8 Pressure curve for CP-7.

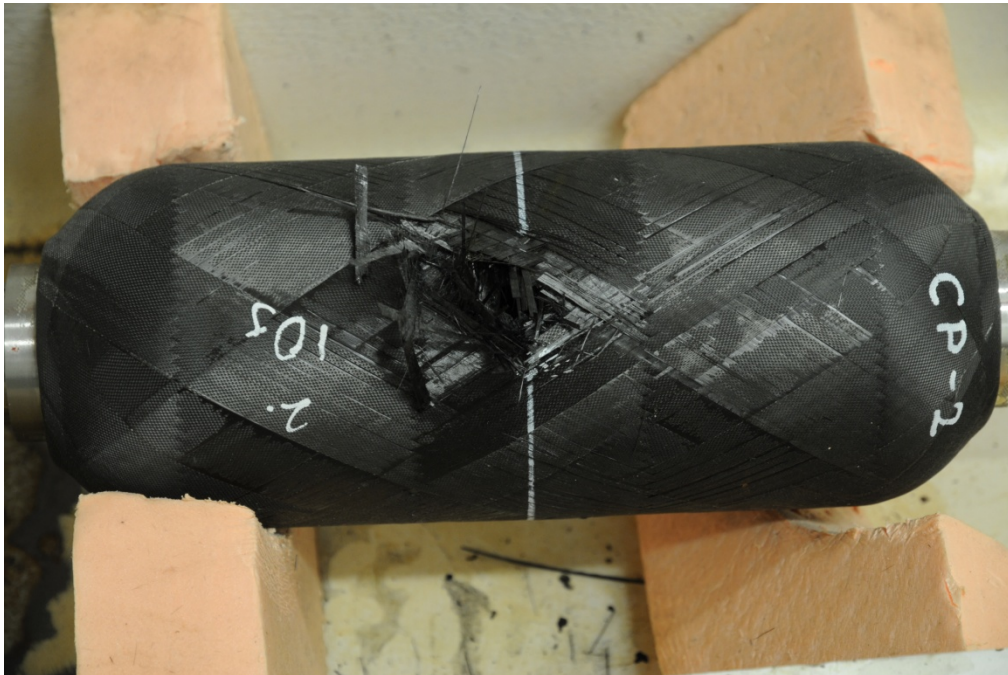
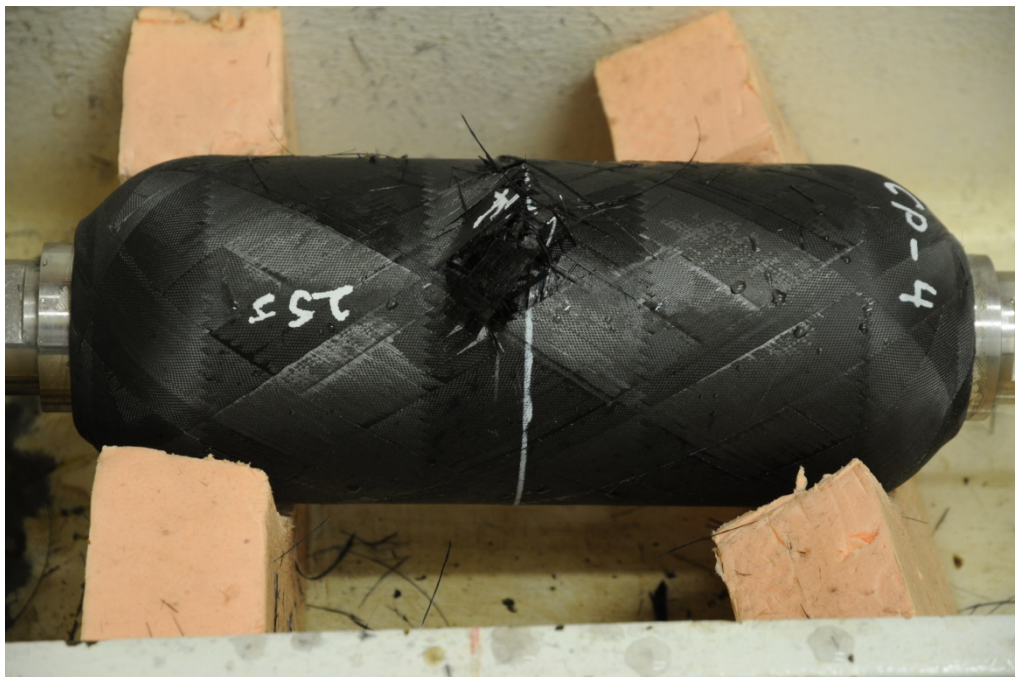
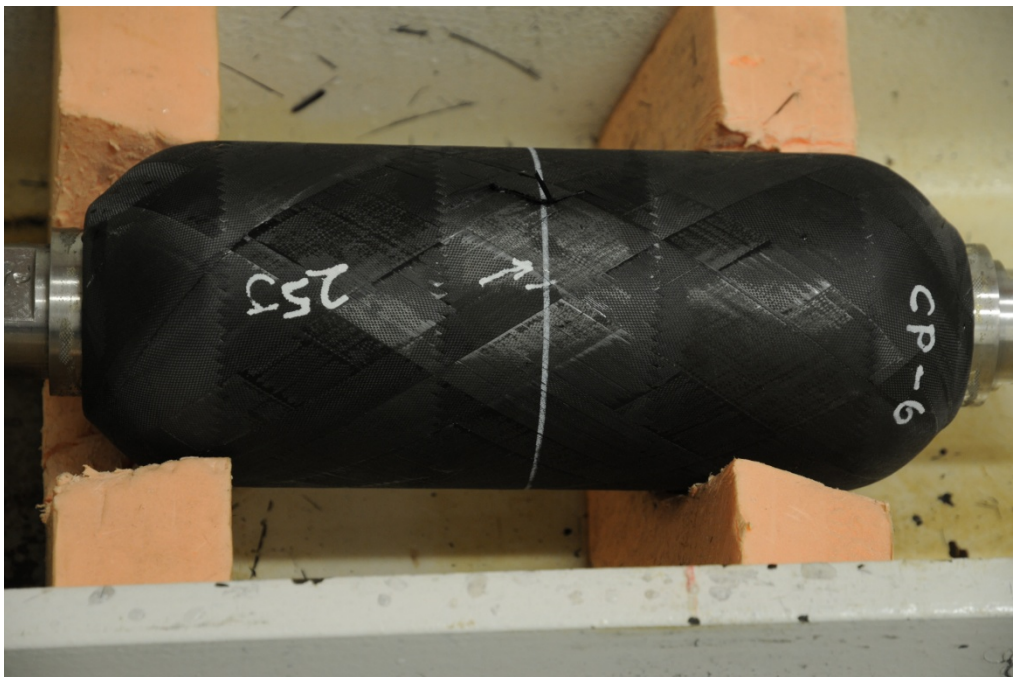
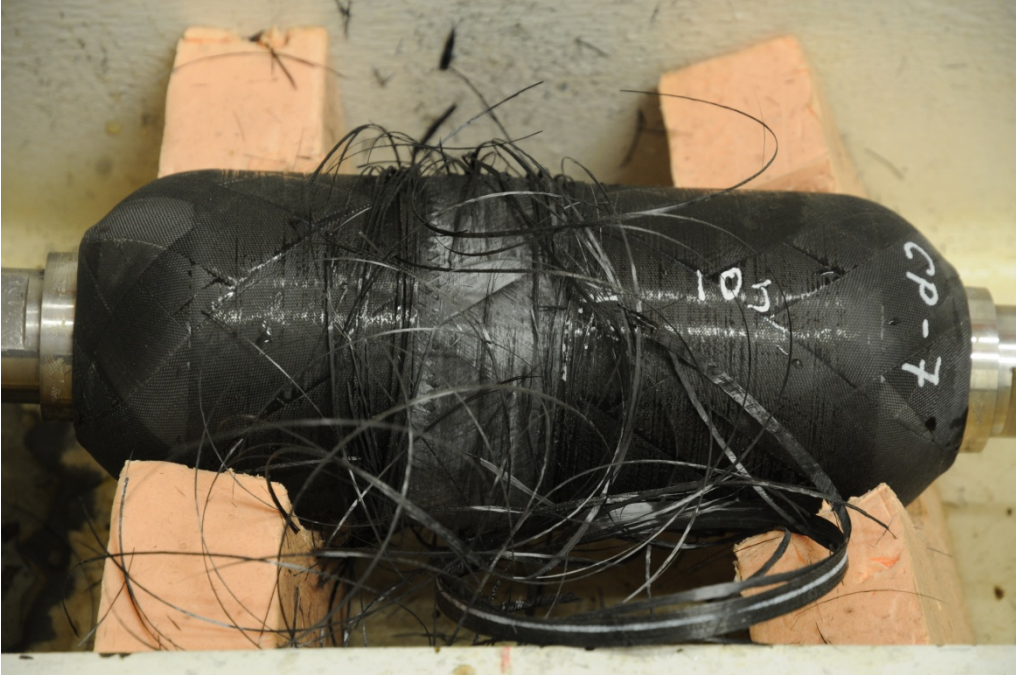
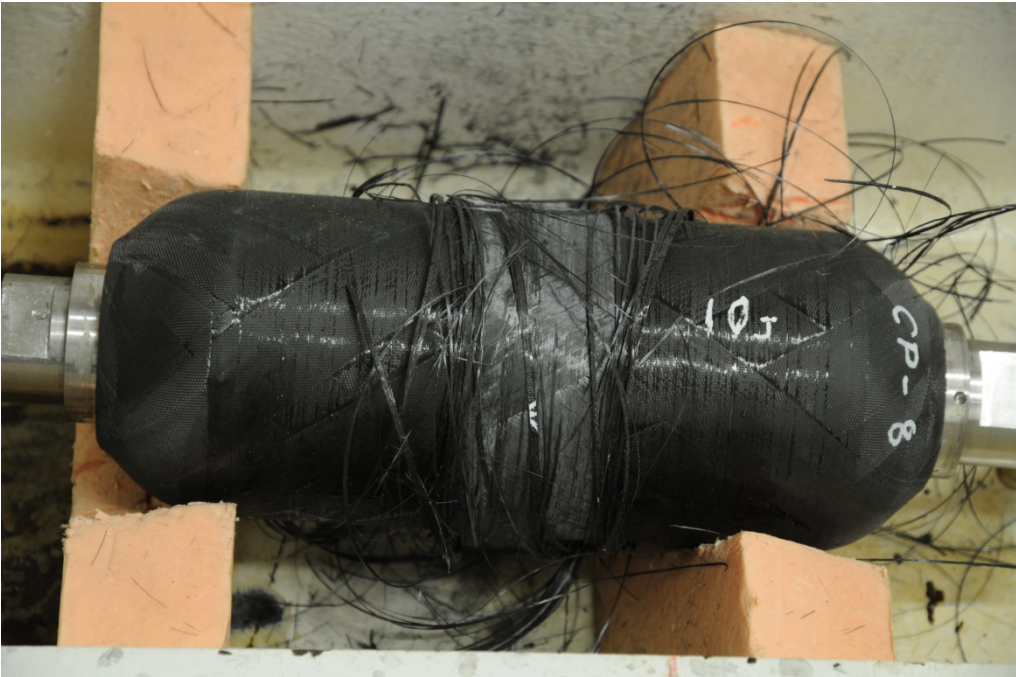
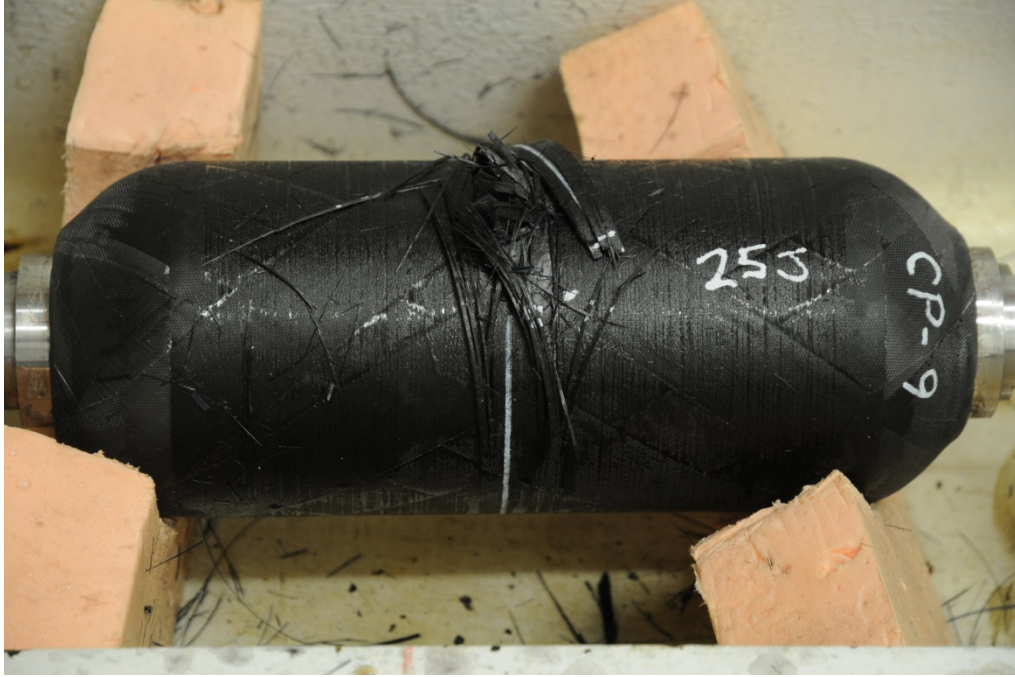
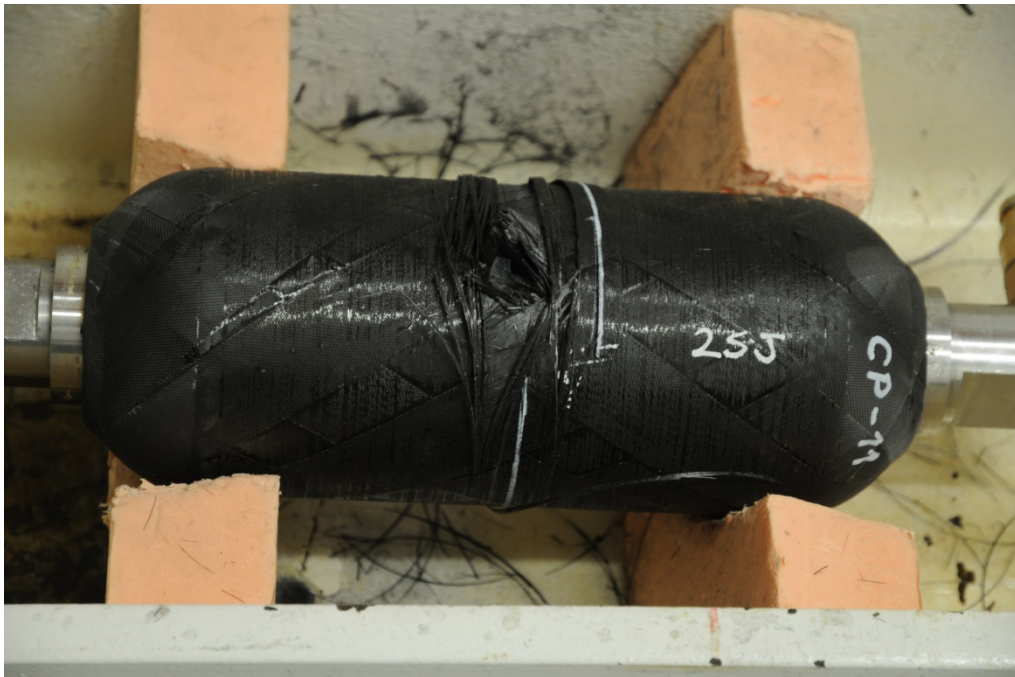
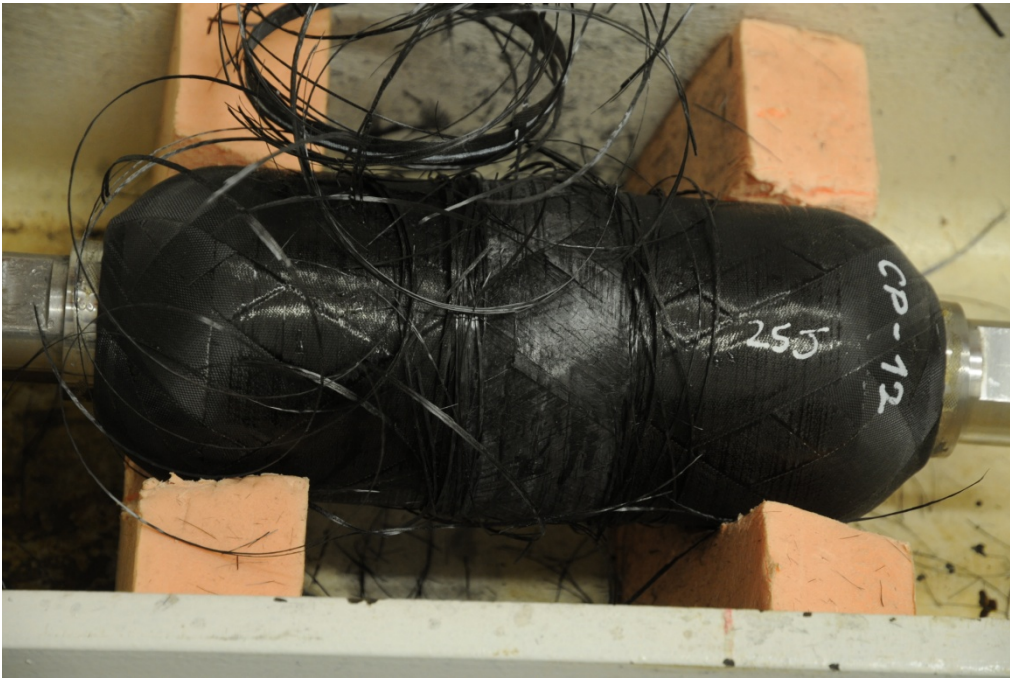
Figure 3.13 to Figure 3.23 display the eleven pressure vessels after burst. The destructed area of the vessels after burst is located around the point of impact.

- The burst pressure of the impacted vessels is a function of the applied impact energy
- The destructed area of the vessels after burst is located around the point of impact
- Compared to non-impacted vessels with lay-up XXO, which have a typical burst pressure of 35 MPa, the burst pressure is reduced to about 14 MPa (approximately 60 % reduction) for the low impact energy level, and to about 12 MPa (approximately 66% reduction) for the high impact energy level
- Compared to non-impacted vessels with lay-up OXX, which have a typical burst pressure of 41MPa, the burst pressure is reduced to about 24 MPa (approximately 41% reduction) for the low impact energy level, and to about 13 MPa (approximately 68 % reduction) for the high impact energy level

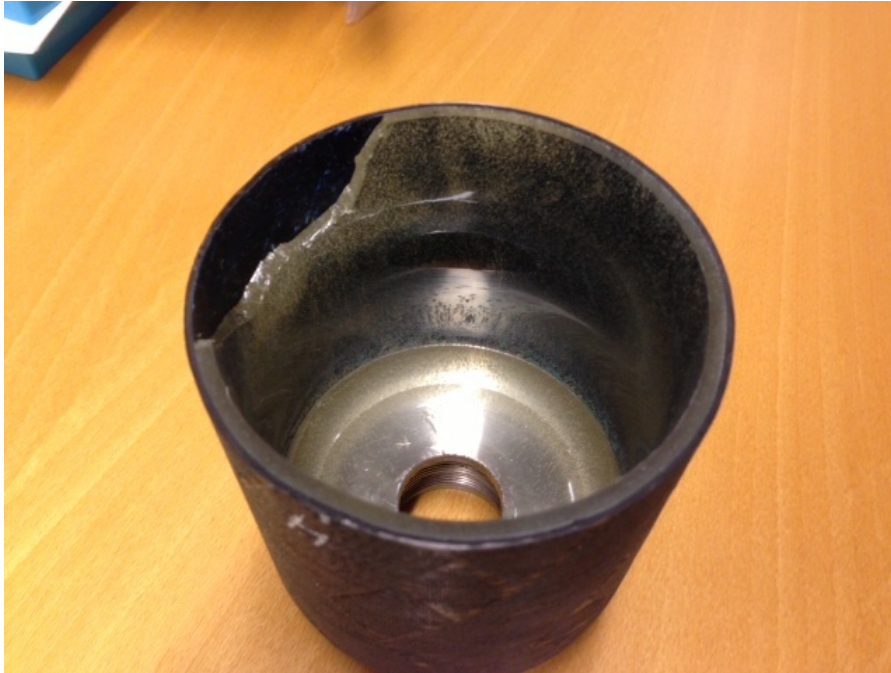
Figure 3.24 Pressure vessel CP-10, which is cut open. The liner thickness is approximately 3 mm.

which probably serves as a load distributor that engages a larger part of the structure. Pressure vessel CP-10 was not hydro burst tested, but instead cut open, as seen in Figure 3.24. For pressure vessel CP-10 the thickness of the liner is approximately 3 mm.
