SENSOR INSTALLATION ON KNM SKJOLD PRIOR TO FIRING TESTS APRIL 2000

FFI/RAPPORT-2000/03665

This document describes the installation procedures and locations of the sensors installed on KNM Skjold in March 2000 and the experience gained from the installation process. The sensors were installed in order to carry out measurements during the Oto Melara 79 mm cannon firing tests in April 2000. The installations were carried out under a separate contract, and not directly associated with the CHESSE project (1). The type, number of sensors and the purpose of the measurements were:

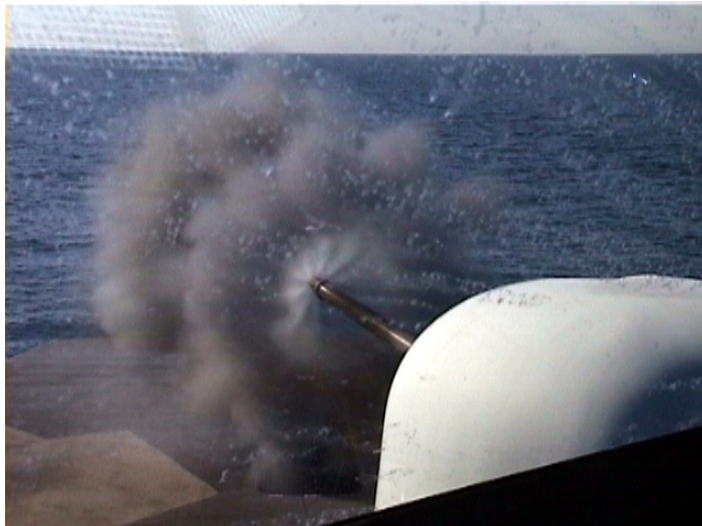
Figure 1.1 The sensor locations as well as some of the gun firing tests have been taped using a mini-DV camcorder. The photos in this report have been taken from this tape. The picture shows the gun immediately after gun test number 19

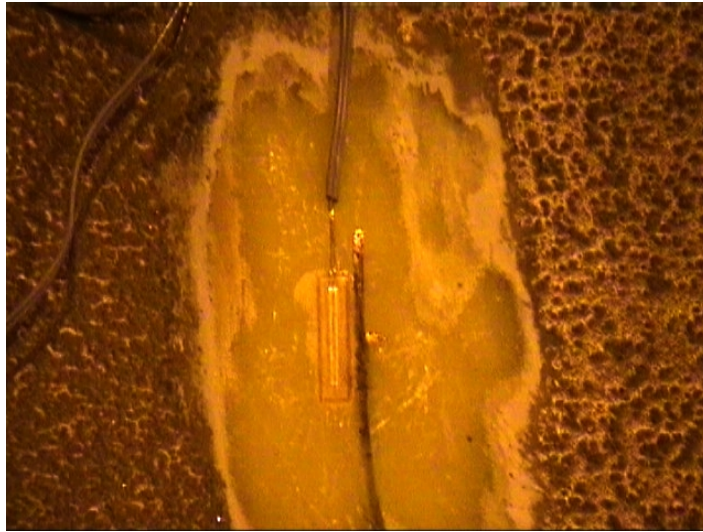
Figure 2.1 Strain gauge mounted on the weather-side of panel G

On the deck, the panel edges were found by measuring the distance to features such as the wheelhouse, the lift fan intake and the hull side. The middle points on the panel edge were marked using masking tape. The positions were checked by tapping the deck to locate the bulkheads. The sensor positions were marked, the surface machine sanded and washed with acetone. After measuring and marking the exact sensor position, the strain gauge (TML PFL-20-11-1L) was affixed using cyanoacrylate.

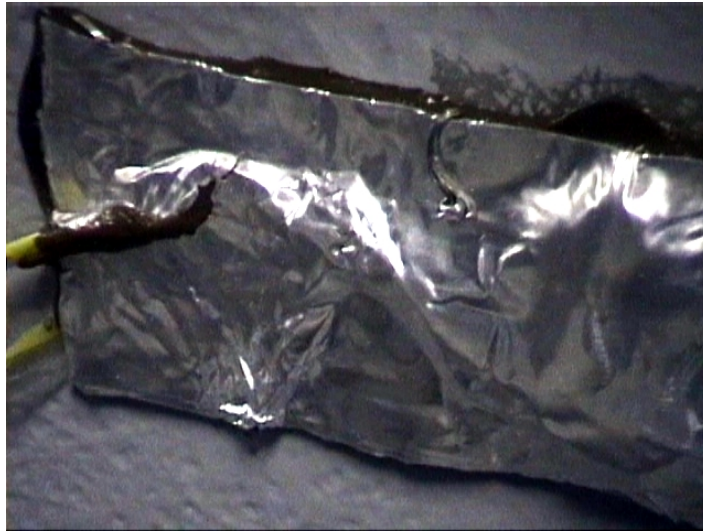
Figure 2.4 Strain gauge with ABM 75 aluminum shield. Notice the ground wire pierced through the foil

The sensor was protected against moisture and mechanical influence using a viscous putty (AK 22, Hottinger Baldwin Messtechnik). Thereafter, the sensor was connected (two wires per strain gauge) to the cable. In order to reduce electromagnetic noise, the connectors, the unshielded wires as well as the sensor were covered by an aluminum foil (ABM 75 from Hottinger Baldwin Messtechnik) which was grounded to the cable shielding by piercing the foil with the ground cable, see Fig. 2.4. Attempts to solder on the cable were unsuccessful. The cabling from sensor area to the three amplifiers (Hottinger, Micro Movements and Vishey 23211) was laid out by electricians. The cables were laid on deck if possible to reduce the electromagnetic interference. Cables routed inside were strapped to ventilation ducts and kept away from other cables if possible.

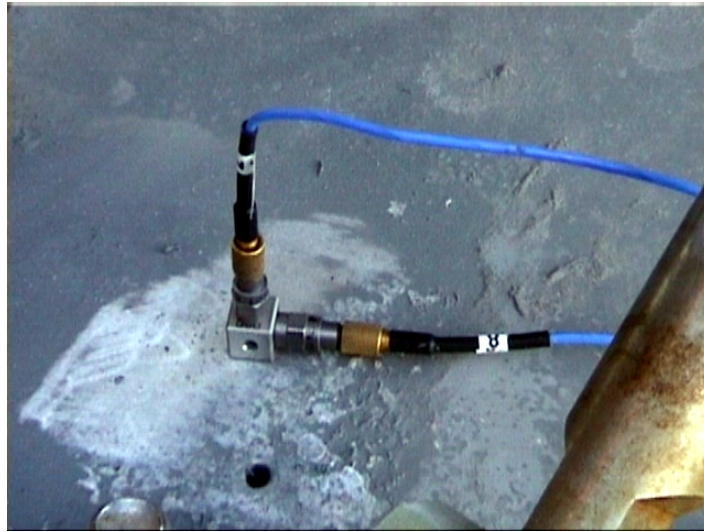
Figure 2.5 Two accelerometers mounted on a precision cube glued to the radar fundament using cyanoacrylate glue

Primarily, we wanted to use a jig with pre-installed accelerometer for all rotation measurements. However, this was possible only in the instrument room (datum) and in the mast. On the gun fundament and on the wheelhouse roof, the surfaces were prepared by grinding and washing, then accelerometer cubes (a cube of approximately dimensions 25 mm×25 mm×25 mm) were glued to the surface using cyanoacrylate. Nuts, in which the accelerometers can be screwed, were affixed to the cubes in advance. Outdoors accelerometers were covered in silicon grease protecting against humidity. Special cables from the accelerometer to the battery-powered amplifier (PCB 480E09) were used, and coaxial cables (RG58) was used from the amplifier to the PC in the operations room. Electricians laid out most of the coaxial cable.

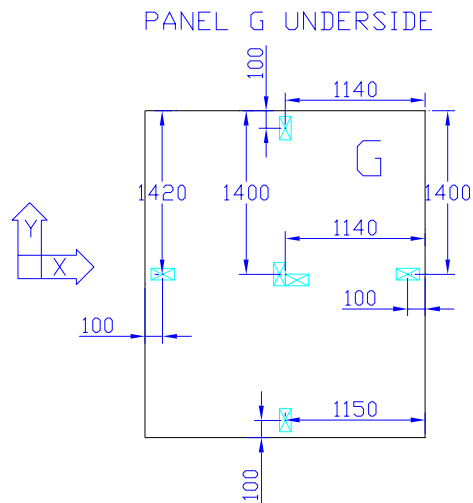
Figure 3.3 Strain gauge installations underneath panel G. The beam measurements are from the inside of the hull

This panel is located above the chief’s cabin. Sensor locations on top and underneath this panel are shown in Figs 3.2 and 3.3 respectively. The installation underneath had to be slightly offset in order to accommodate nails holding sound and fire insulation panels in the roof.

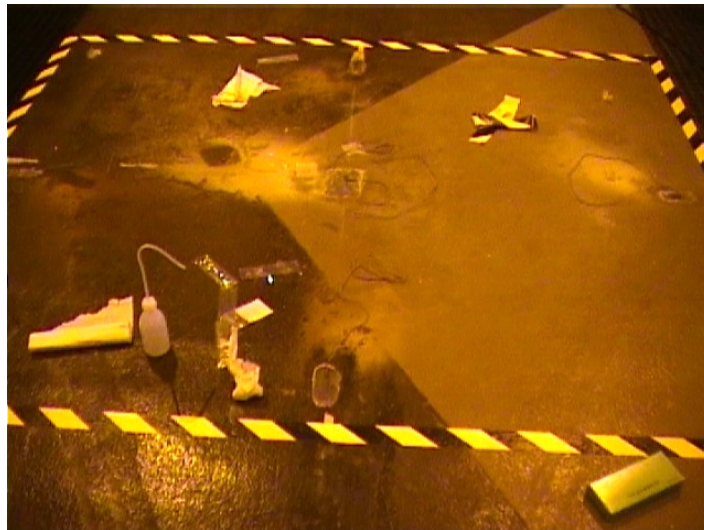
Figure 3.7 From the installation on the weather side of panel 5

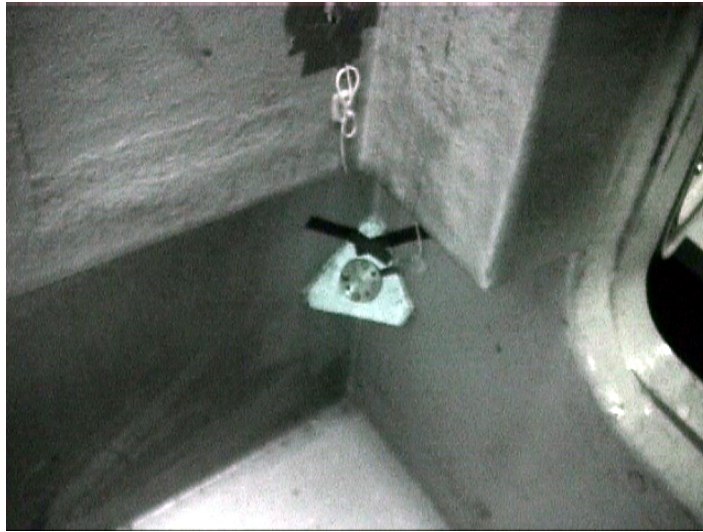
Figure 3.12 Pressure sensor P5 was mounted in a Styrofoam holder somewhat above the lower corner on the forward port side in the lift fan room

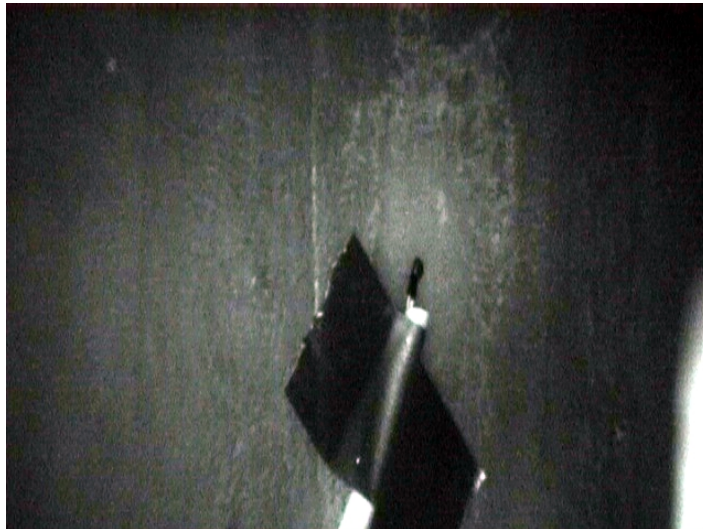
Figure 3.13 Pressure sensor P6 was mounted on the aft side of panel H, facing the forward lift fan

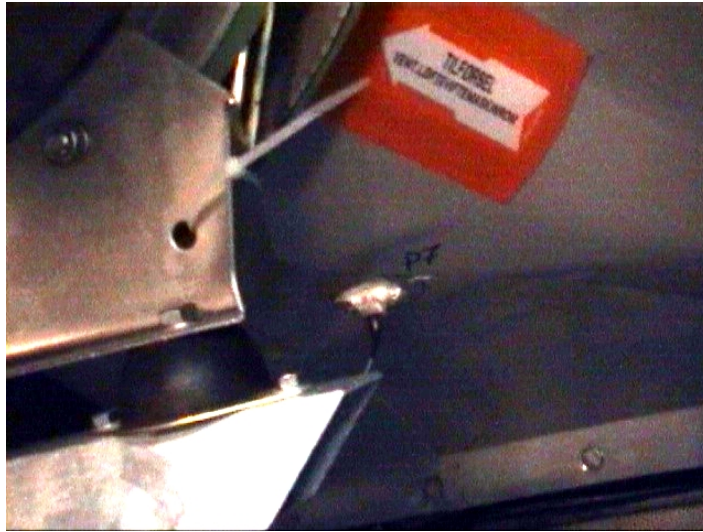
Figure 3.15 Pressure sensor P7 was mounted in a Teflon holder. The holder was inserted in a 16 mm diameter hole in the air inlet and fixed using Sikaflex

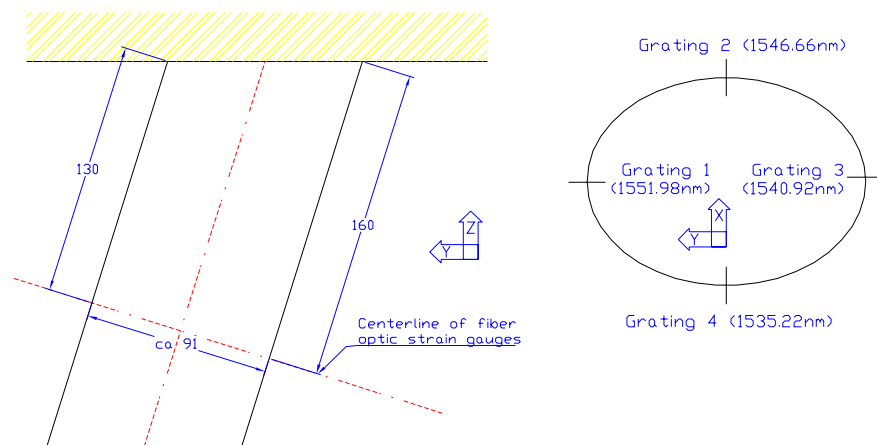
Figure 3.18 Fiber optic strain sensor locations on column 6 of the fundam

Five accelerometers were mounted on top of the fundament (on deck), see Fig 3.17. The measurements are supported with four fiber optic strain gauges on one (column 6) of the eight fundament columns. The locations are shown in Fig 3.18.

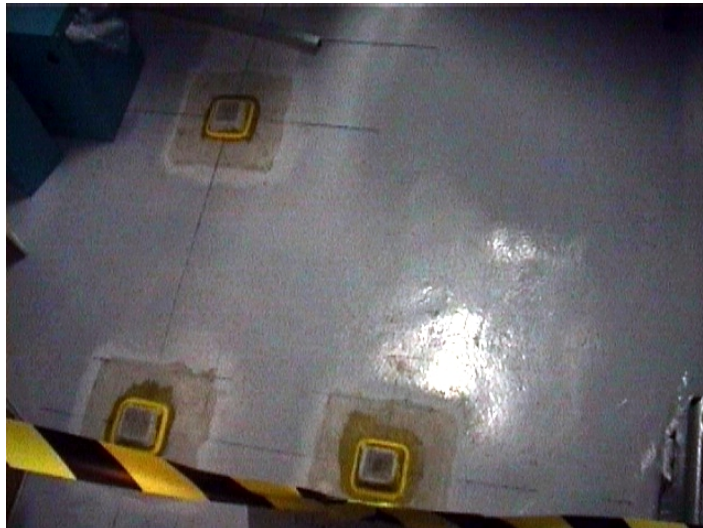
Figure 3.21 Hats on the instrument room floor onto which the jig for rotation measurements was mounted

A rotation measurement jig was built in order to get best possible rotation estimations. The reference surfaces were milled such that they were parallel, thus their relative positions were known accurately. Umoe Mandal provided “hats” with M8 threads for installation of the jig. The position of the threads did not allow alignment of the jig in parallel to the x- and y-axes of the vessel. For installation coordinates, see Fig 3.20.

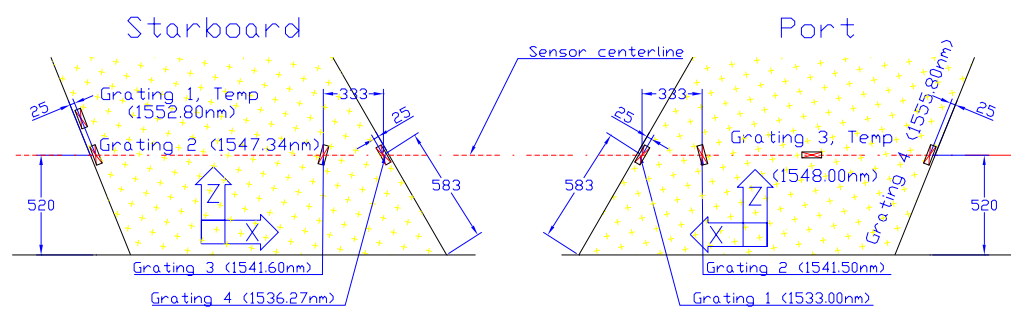
Figure 3.23 Fiber Bragg grating installation on the legs of the mast

In addition, the mast measurements were supported by use of 3 fiber optical sensors on each of the two legs at top bridge level. All sensors were located on the outside of the mast. Details concerning the locations are presented in Fig 3.23.

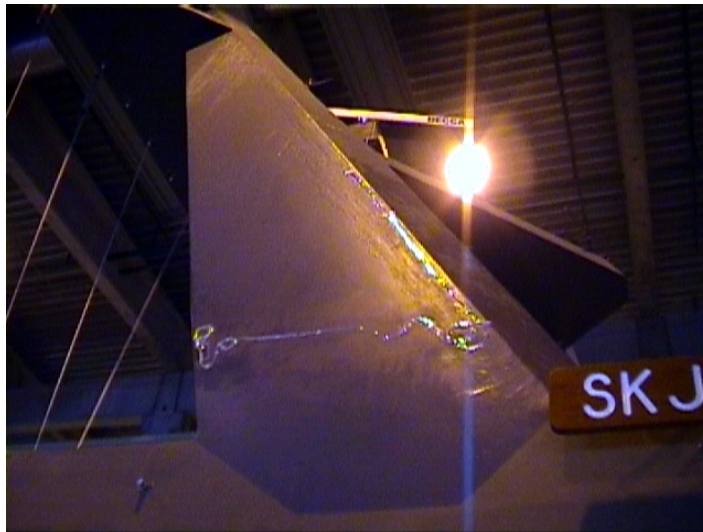
Figure 3.24 Fiber Bragg grating installation on the starboard side mast

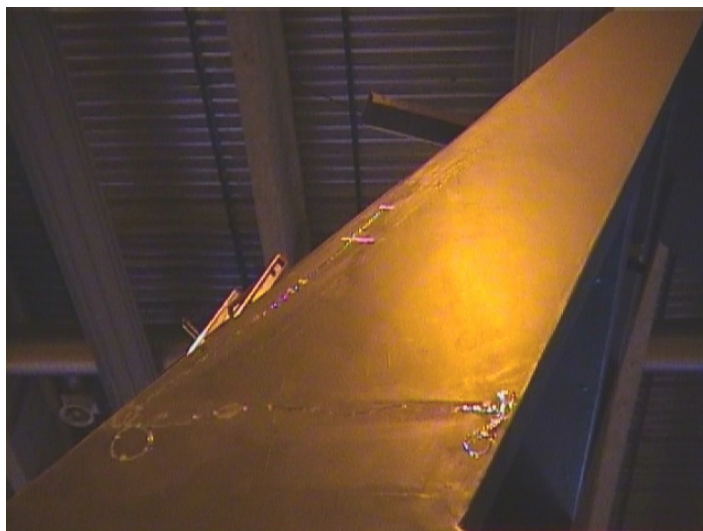
Figure 3.25 Fiber Bragg grating installation on the port side mast

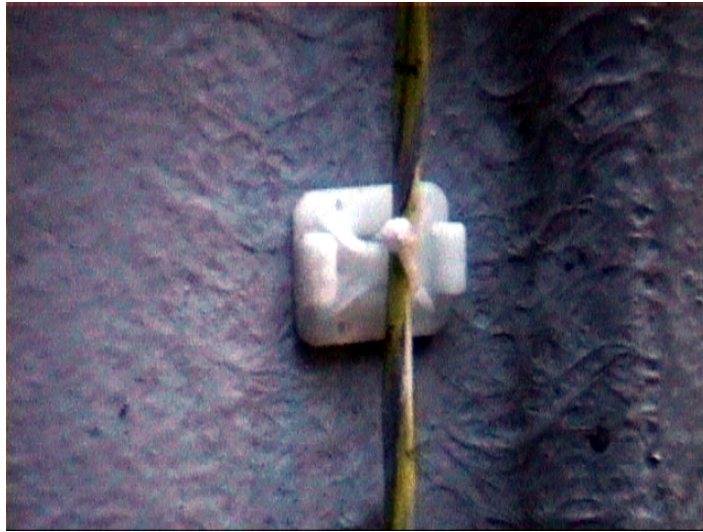
Figure 4.1 The strips pads were affixed to the wall using the supplied double sided tape after cleaning with Kleener Blå

Cabling inside the fan engine room was strapped onto strips pads. The pads were affixed using the double sided tape on the pads. After the experiments, some pads were loose. This occurred on the beams where where the pads supported several heavy cables, and on the underside of panel 5. The pads adhered well on the walls. In new experiments, affixing pads using Sikaflex should be considered in cases where heavy cable is attached or when placing pads on horizontal, wet surfaces. Surface cleaning is also important. We found that cleaning the surface with detergents, ethanol or acetone did not give satisfactory adherence. However, a cleaner spray for electronics, *Kleener Blå, Spray Master, Vallentuna, Sweden*, containing 30-60% alicyclic hydrocarbons, yielded good results.

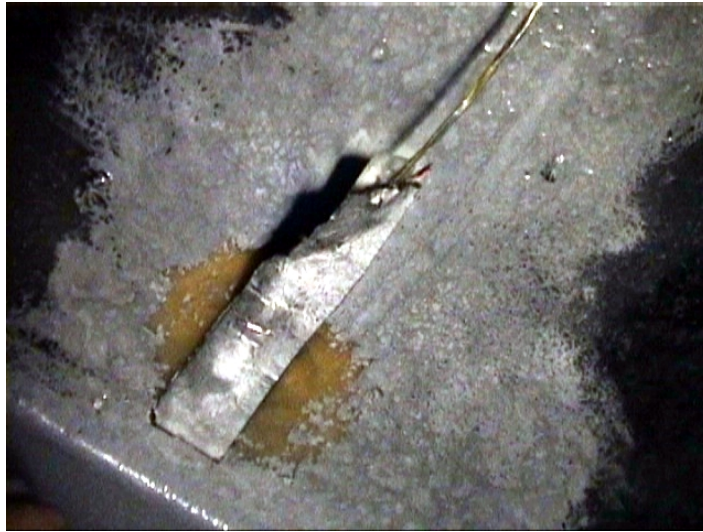
Figure 4.2 Some of the ABM 75 foil covered putty and strips pads fell off under panel 5. This did not affect the measurements, but should be noted in case a long-term measurement is initiated

The putty AK-22, used for protecting strain gauges, adhered well to the surfaces. However, the aluminum foil covered ABM-75 putty did partly fall off in one location under panel 5.
